Your survey report

160 Dartmath Road, London, United Kingdom, SE22 3LQ

21/01/2025

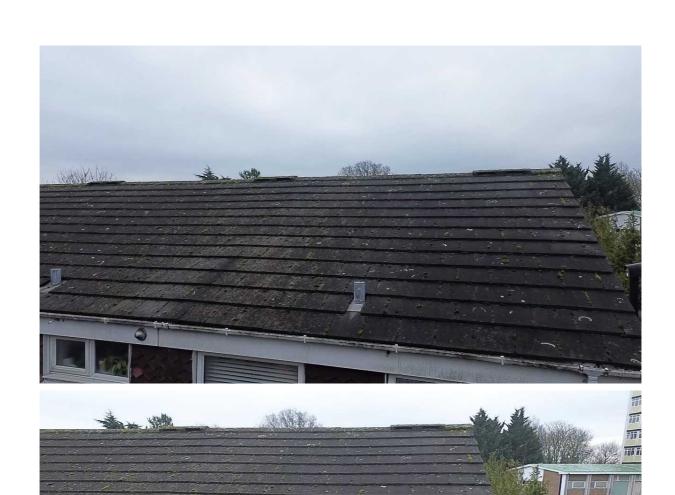
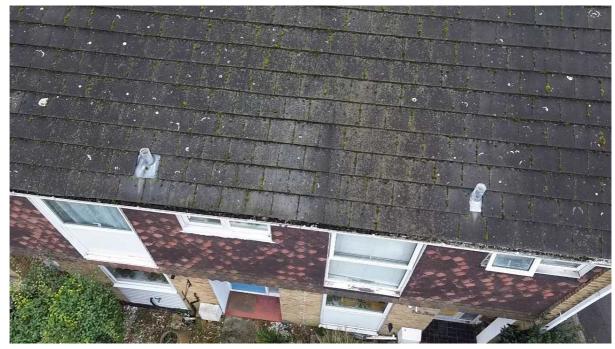
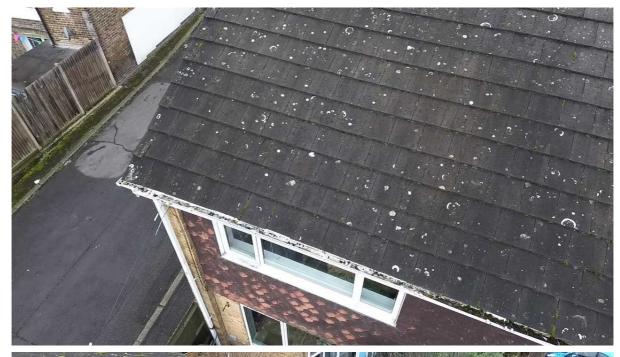
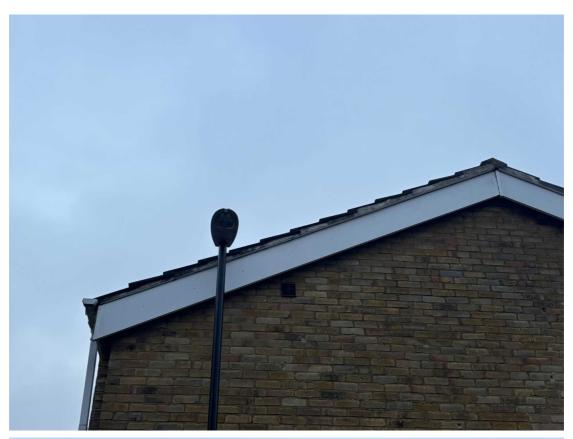
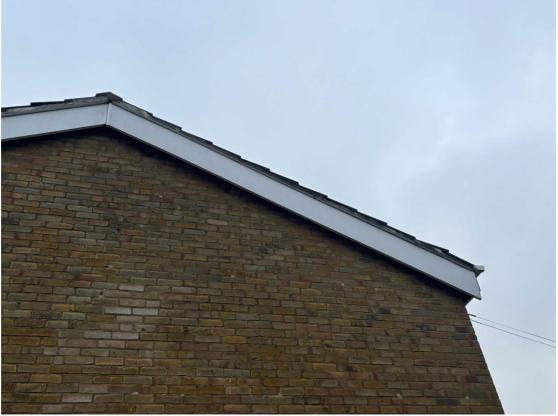
The roof is covered with concrete tiles, which appear to be in good condition overall. Moss is present on some of the tiles, which should be monitored and cleared to prevent water retention and potential damage over time. There are no missing tiles, and the ridge line remains straight with ridge tiles in good order. Ridge vents are properly installed and functioning as intended.

The fascia and bargeboards are in good order, and the verge mortar is intact with no signs of deterioration. The soffits are generally in good condition, except for the front corner soffit boards, which show slight degradation and looseness. These should be repaired or replaced to prevent further issues.

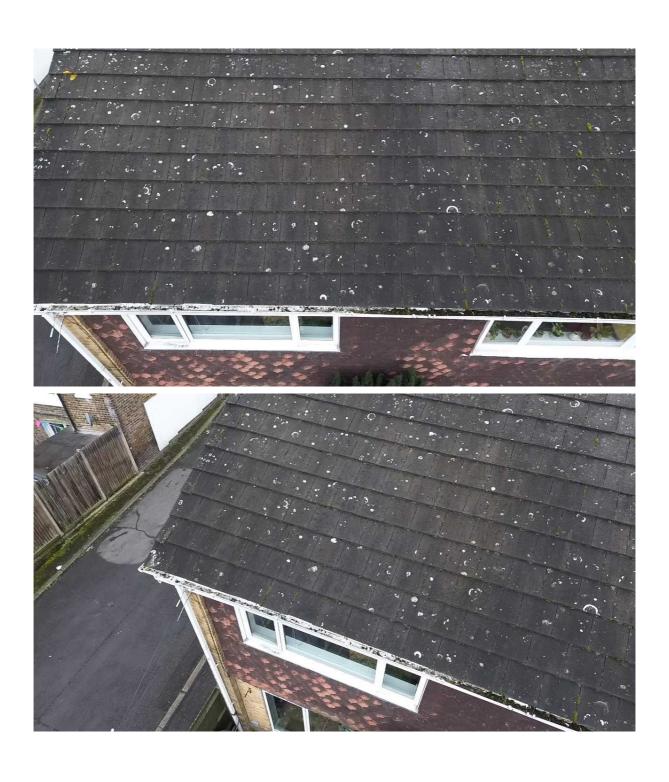
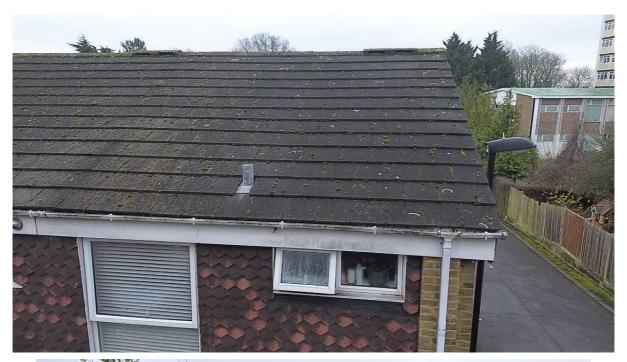
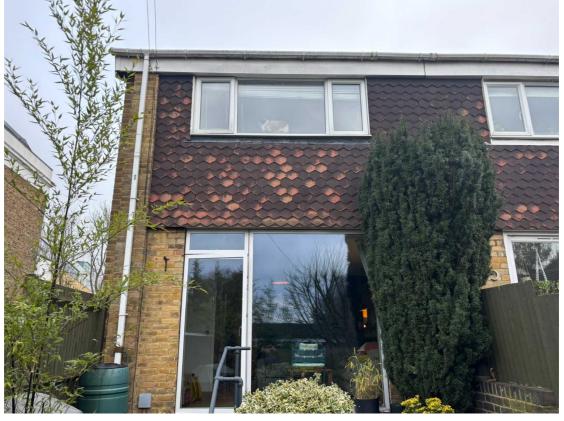
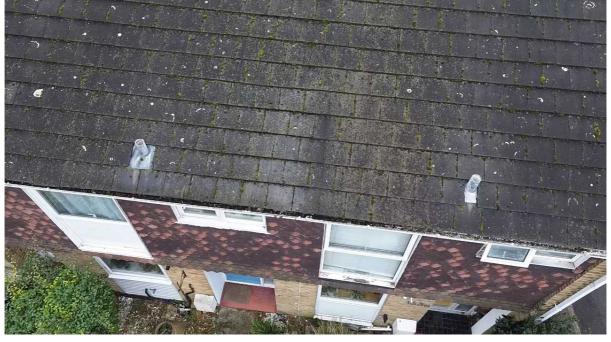
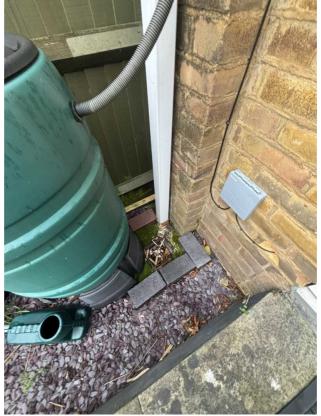
D3 Rainwater pipes and gutters

The guttering, downpipes, and gullies are overall in good order. The fixings are secure to the fascia, and the expansion joints are adequately placed, allowing for proper movement. There are no missing or damaged sections of the guttering, and the fixings to both the fascia and brick wall are securely in place. There are no obvious signs of water staining on the façade, indicating that drainage is functioning as expected.

Some debris accumulation was noted in the gutters during the drone survey, which will need to be cleared to maintain proper drainage. The downpipes run into gullies, both of which have some debris accumulation—one at the front and one at the back of the property. These should also be cleared to ensure effective water flow and to prevent potential blockages.

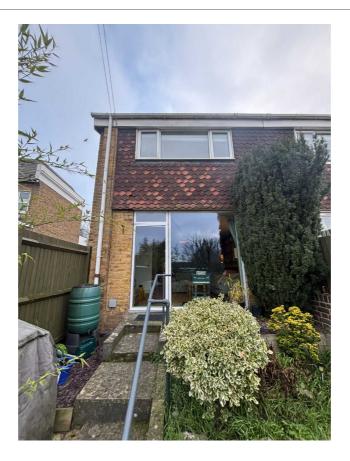
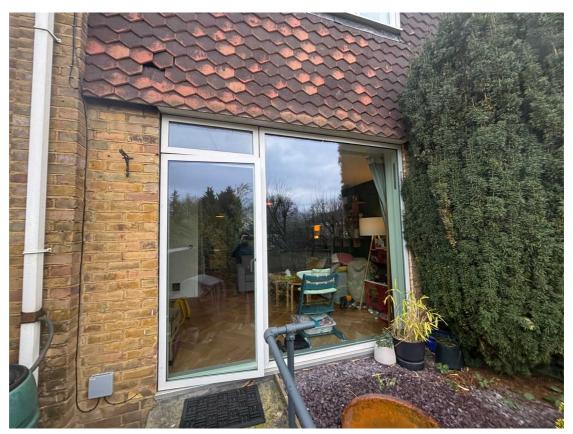
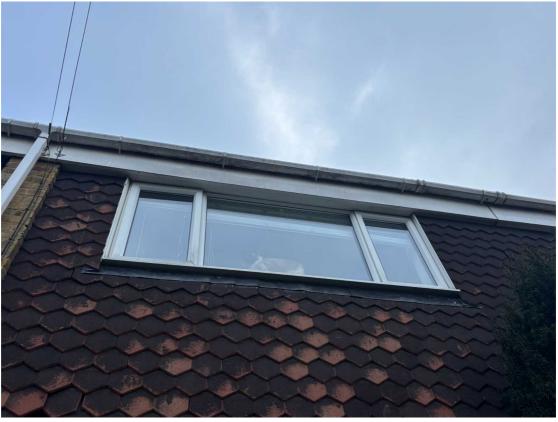
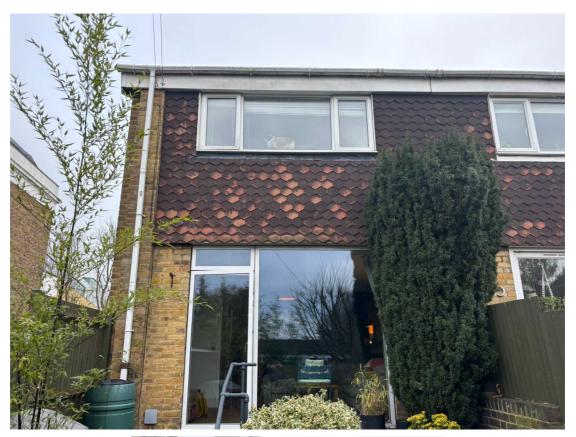
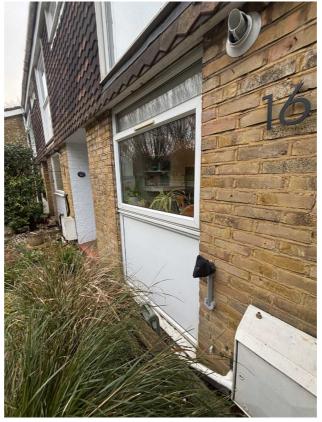
The main walls of the property consist of a mix of exposed brick and tiles. The brickwork is in good condition, with the pointing also in satisfactory order. There are no visible cracks or signs of bowing in the walls that would suggest subsidence, heave, or any structural movement.

The tiled sections are generally in good condition, although some weathering has caused minor staining to the tiles. One tile is missing from the rear of the property. While this does not appear to have had a detrimental effect on the structure, it will need to be replaced to prevent potential water ingress and further damage.

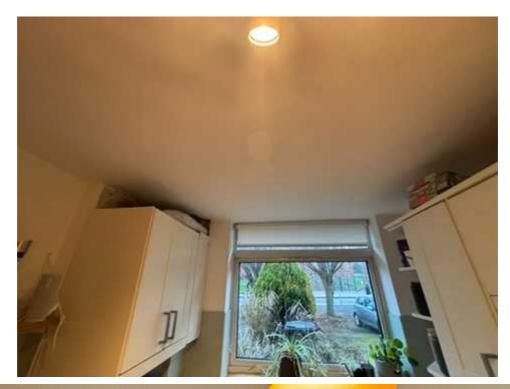
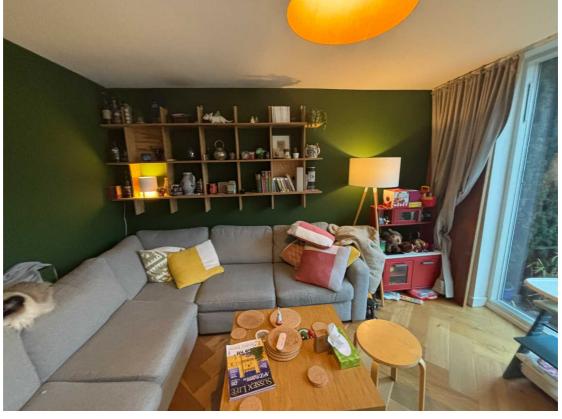
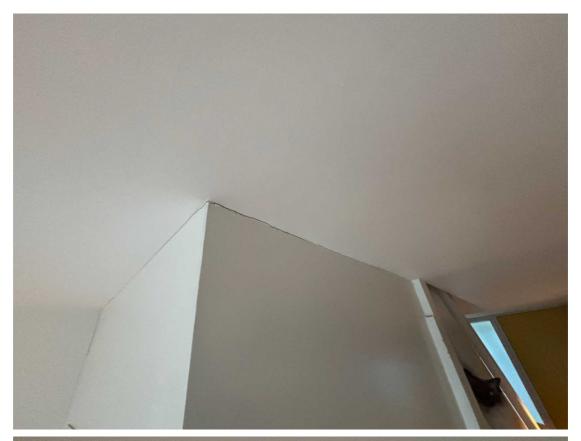
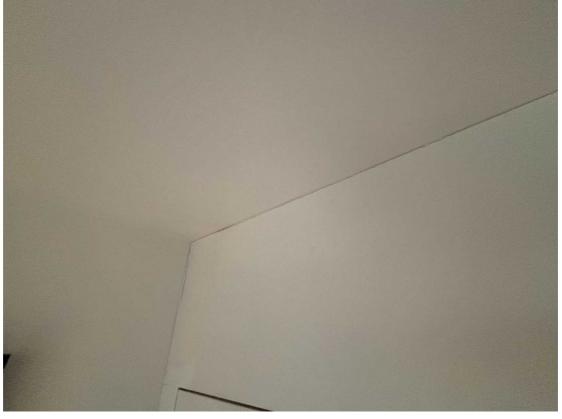
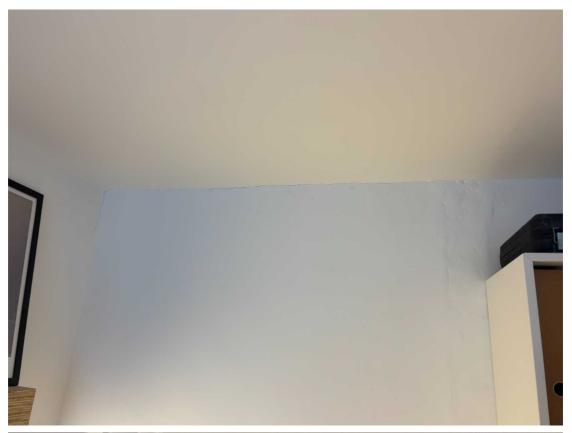
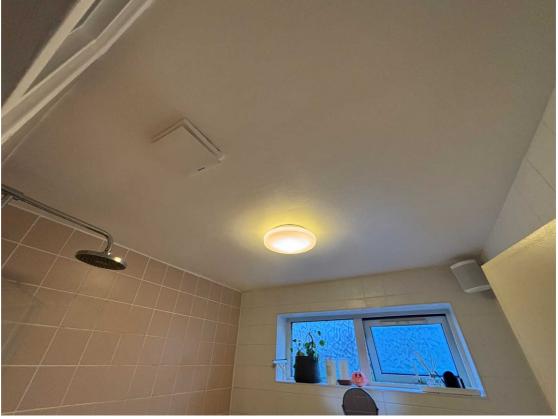
E2 Ceilings

The ceilings throughout the property appear straight and level, with no significant signs of distortion or sagging. There are some minor hairline cracks in places, which are common in many properties and can easily be filled and redecorated to restore the smooth finish. These small imperfections do not indicate any underlying structural issues.

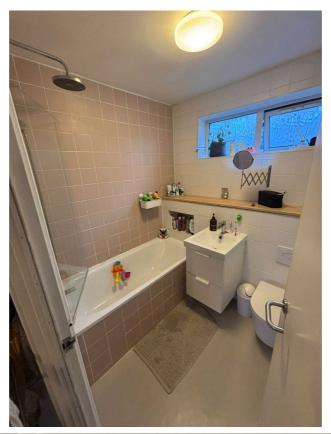
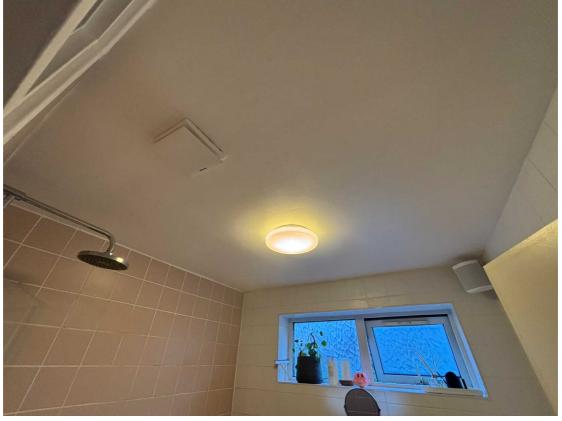
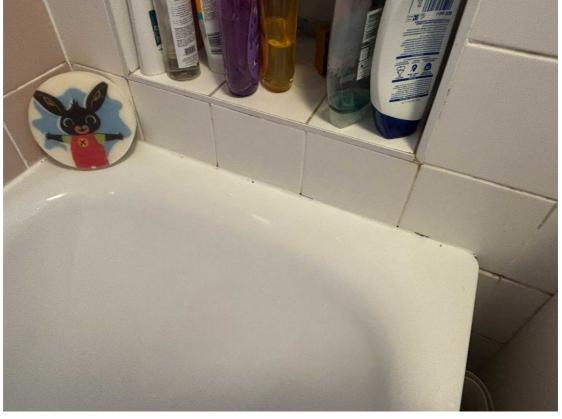
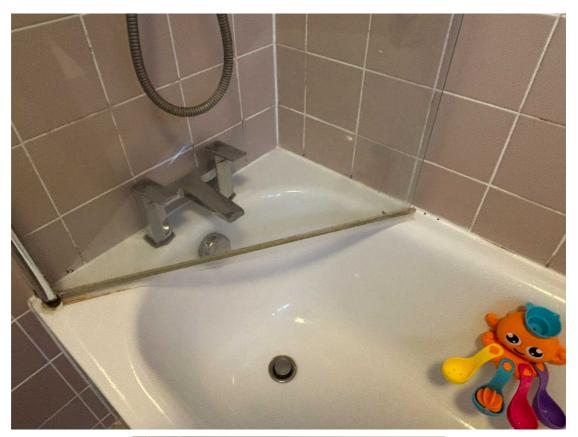
E8 Bathroom fittings

The bathroom is in good condition overall, with the sanitaryware in good order, showing no signs of damage or wear. The tiles are well-maintained, with no cracked or missing sections, and they contribute to the overall aesthetic of the room. However, the grout joints have become discoloured and show signs of minor mould growth, which suggests that a deep clean would be beneficial to restore their appearance and prevent further mould buildup.

The mastic around the bath and sink is intact, but, like the grout, it shows minor mould growth in places. This can be cleaned or replaced as part of routine maintenance to maintain hygiene and prevent any further mould spread.

The shower screen and chrome fixtures require a deep clean as part of general maintenance. The buildup of soap scum and watermarks is common in these areas and can be addressed with a thorough cleaning to restore their shine and keep the bathroom looking its best.

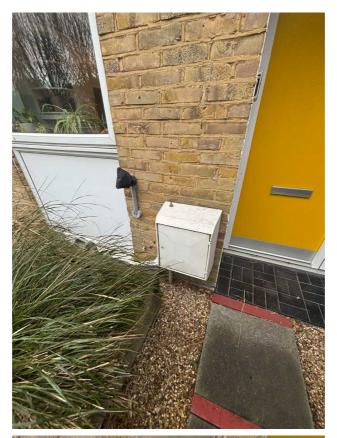
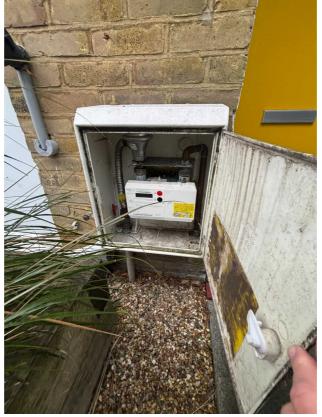
F2 Gas/oil

The gas meter is located outside the property, secured to the external wall in a meter box. The box is in generally good condition, providing adequate protection for the meter from the elements. However, the box shows some signs of external staining and weathering, which is typical for units exposed to outdoor conditions. The gas meter itself appears to be securely installed and accessible for reading and maintenance.

It is important that the gas meter is regularly checked, and the meter box should be kept closed and securely latched to protect the meter from debris, moisture, or potential tampering. While there are no immediate concerns noted, it is always advisable to ensure that the gas meter and its connections are regularly inspected for safety by a Gas Safe engineer

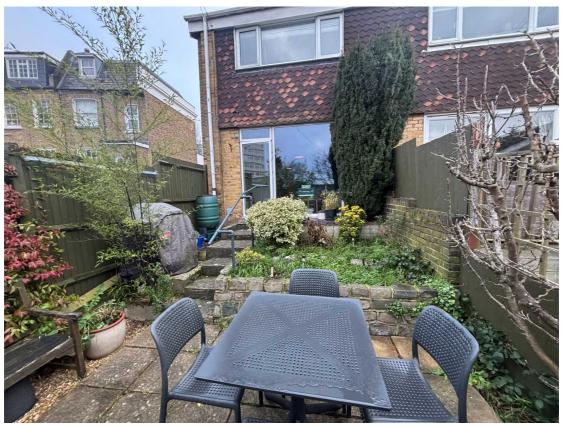
Overall, while the tree is not currently causing issues, it is wise to remain vigilant to avoid potential future complications. Regular maintenance of the tree and the structure of the house will help mitigate any risks.

- Regular Monitoring: It is recommended that the tree be monitored regularly, especially as it
 matures, to ensure that its growth does not start to affect the house. If the tree shows signs of
 being too close to the property, its growth can be managed, or it may need to be pruned or
 even removed to mitigate any potential risks in the future.
- **Tree Inspection:** Consider consulting with an arborist or tree specialist who can assess the tree's proximity to the house and provide advice on whether any action is required.
