Your survey report

## **About the inspection**

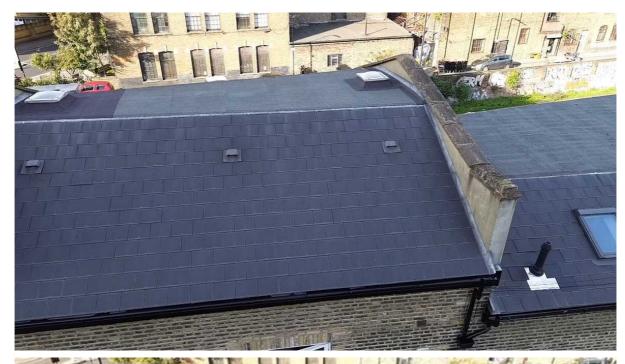
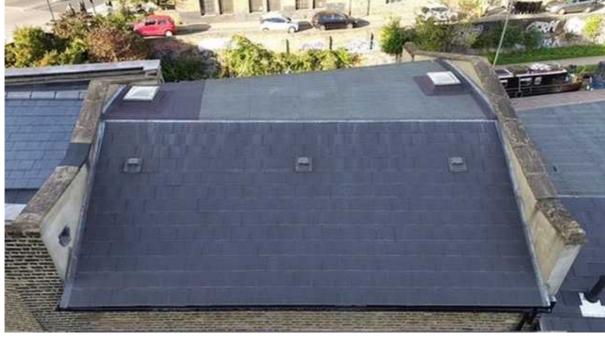
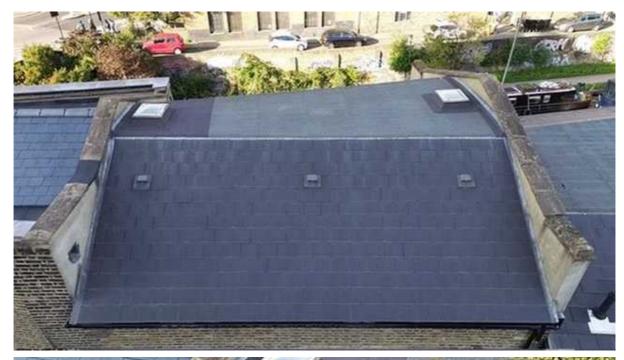
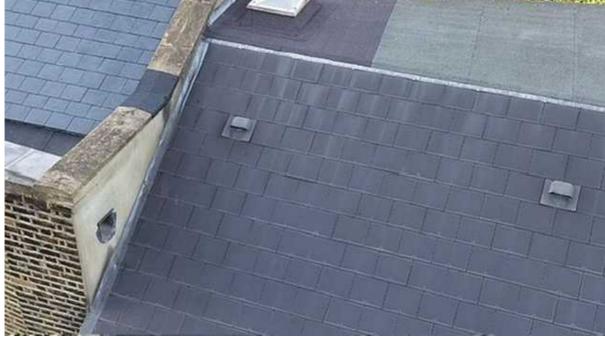
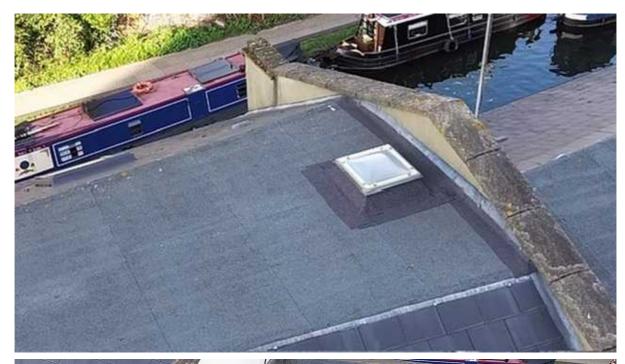
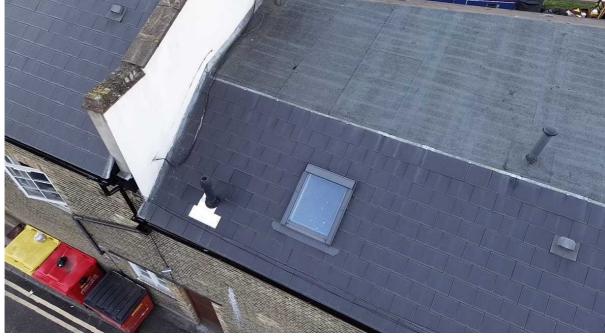
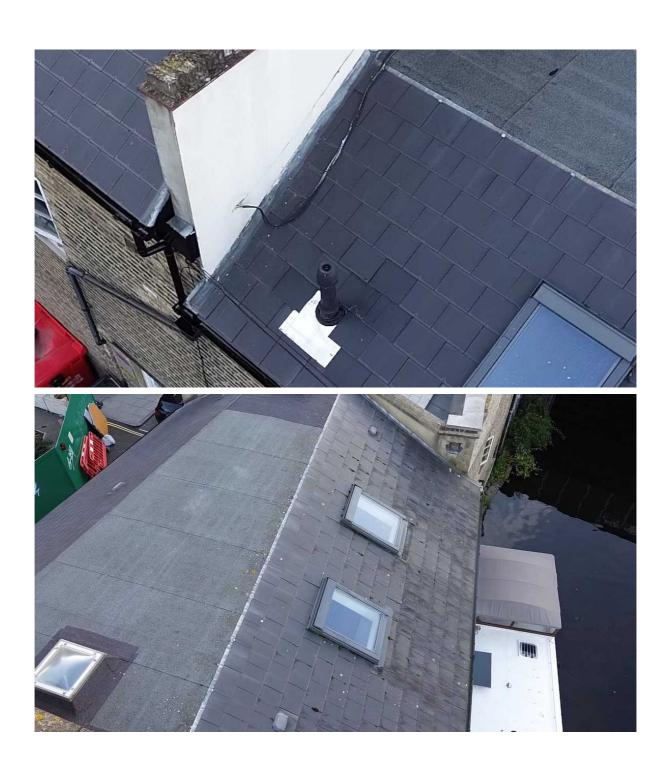
The roof structure of the property features a dual design comprising two pitched roofs clad in modern tiles, complemented by a flat felt roof. The tiled surfaces are generally in good condition; however, it has been noted that several tiles are missing around the vent pipe. Presently, this does not pose a significant issue, as the flange of the vent sleeve effectively maintains waterproofing. Nevertheless, it is prudent to address the missing tiles in the near future to prevent potential water ingress.

The flat roof's felt waterproofing exhibits sound integrity, with appropriate lapping around the rooflight upstands, ensuring effective drainage and minimizing the risk of leaks. During the inspection, no significant damage was observed on this surface. Additionally, the flashings are installed correctly, featuring adequate expansion joints to accommodate movement and prevent cracking. The party wall and coping stones are also in good condition, contributing to the overall structural integrity and durability of the roof system. Regular maintenance and monitoring are advisable to preserve the roof's functionality and longevity.

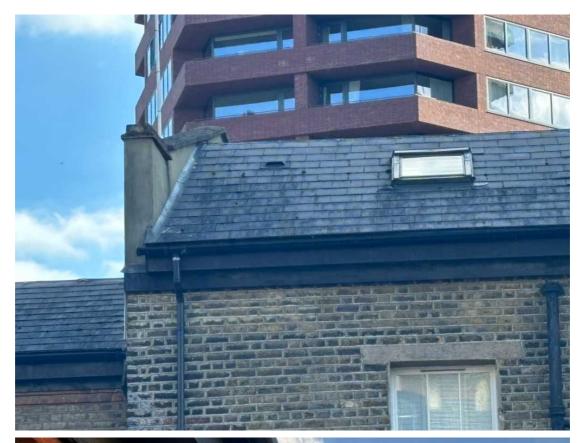
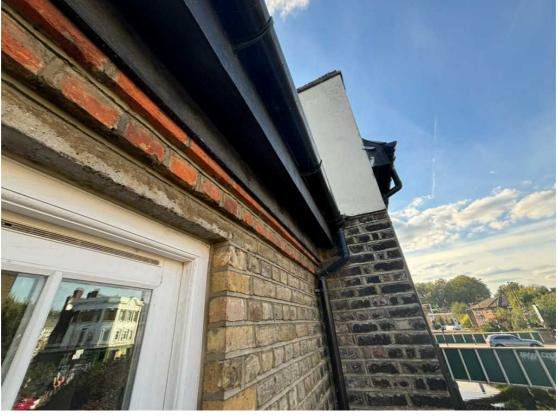
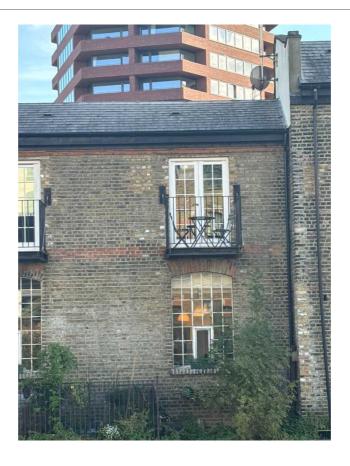
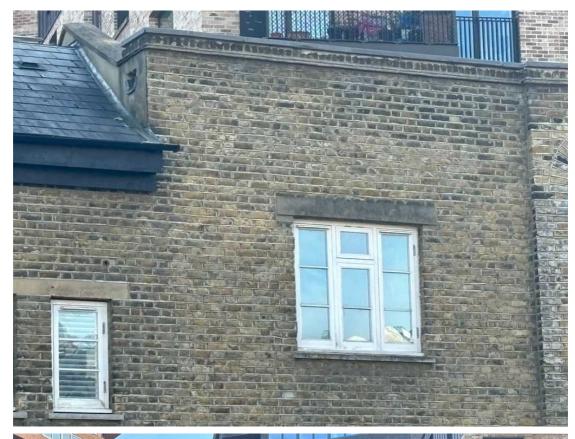
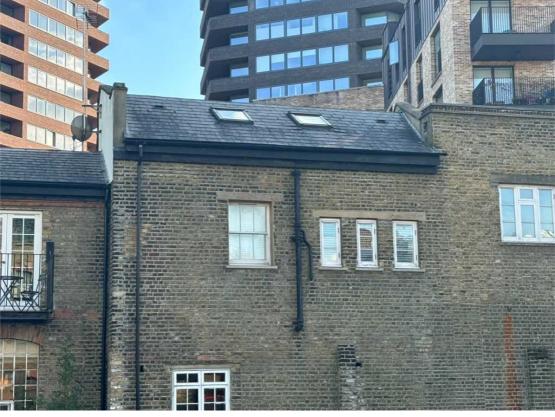
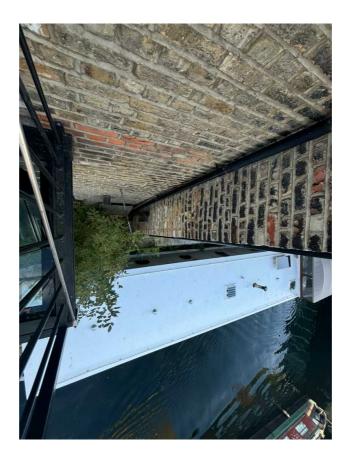
The main walls of the property are solidly constructed from high-quality brick, with no missing or damaged bricks observed. The mortar joints are in excellent condition, negating the need for any repointing at this time. Importantly, the walls show no signs of deformation or cracking, indicating no structural movement. Furthermore, the concrete lintels above the openings are intact and free from cracking, reinforcing the overall structural integrity of the property. Regular inspections and maintenance will help ensure the long-term durability and visual appeal of the brickwork.

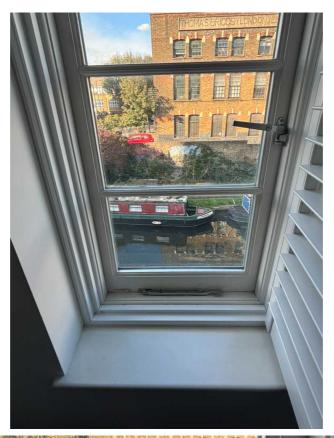
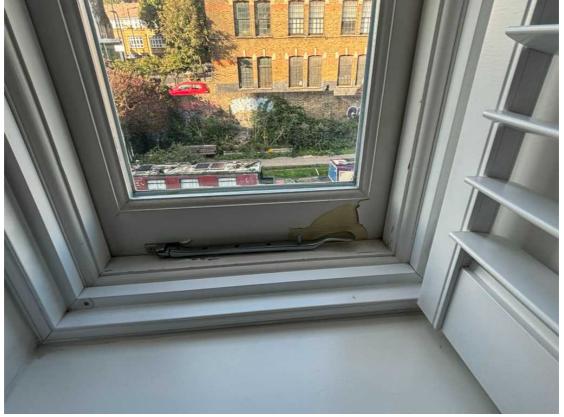
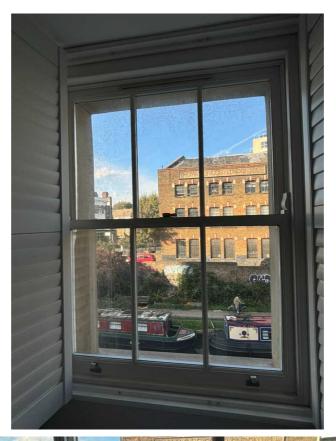
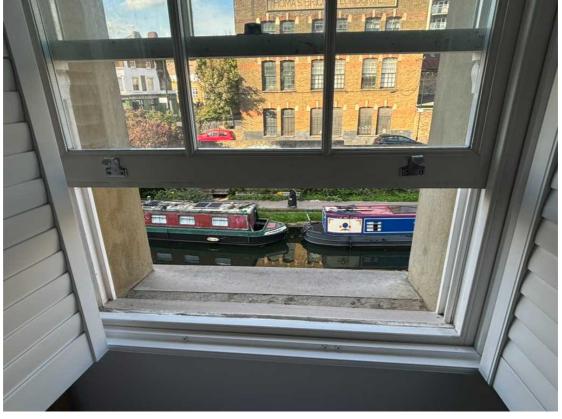
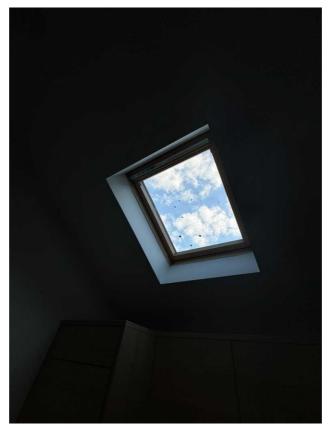
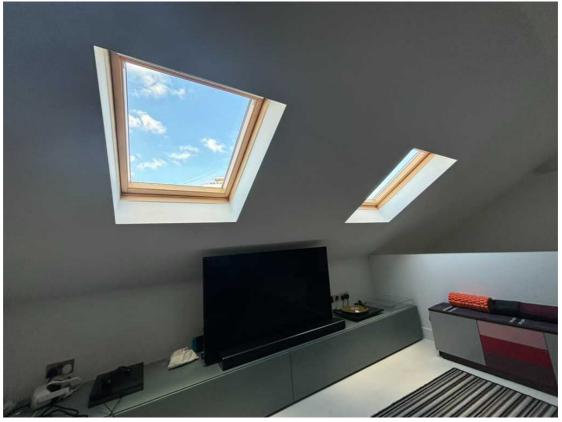
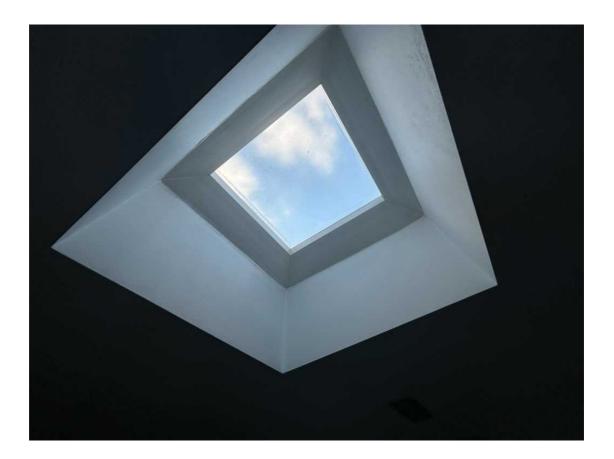
#### **D5 Windows**

The property is equipped with high-quality double-glazed windows and doors, including those leading to the balcony and Velux roof lights. All windows were found to be fully operational, providing effective insulation and soundproofing. While minor paint flaking was observed on the internal window frames, this cosmetic issue does not impact the overall performance of the windows and can be easily addressed with simple redecorating.

Importantly, there were no cracked or damaged glass panes, and the seals were in excellent condition, with no evidence of condensation between panes, which suggests the seals remain intact and functional. The roof lights in the upstairs bedroom were fully operational, allowing for natural light and ventilation, although the kitchen roof light was not assessed due to high ceilings. Additionally, no signs of leaks were detected around the windows, indicating a strong and effective seal. Overall, the windows and roof lights contribute positively to the property's aesthetics and functionality.

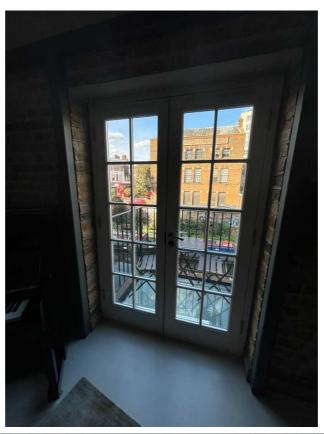
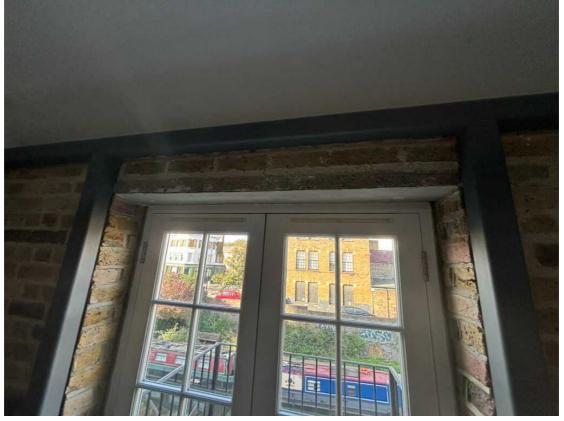
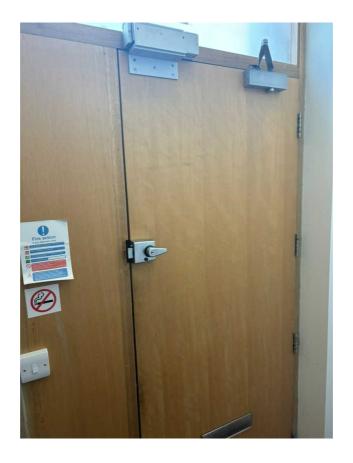
#### D6 Outside doors (including patio doors)

The outside doors of the property are well-maintained and functional. The double doors leading onto the balcony are in good condition, operating smoothly without issues and equipped with locks for added security. It is advisable to consider repainting the timber threshold soon to enhance its durability against the elements.

The front door features solid construction and a stylish finish, contributing to the property's overall appeal. Importantly, there is no evidence of warping or bowing that would affect its performance. Its effortless operation and excellent sound insulation qualities ensure a quiet indoor environment, reflecting quality craftsmanship. Regular maintenance will help preserve these doors' integrity and aesthetics over time.

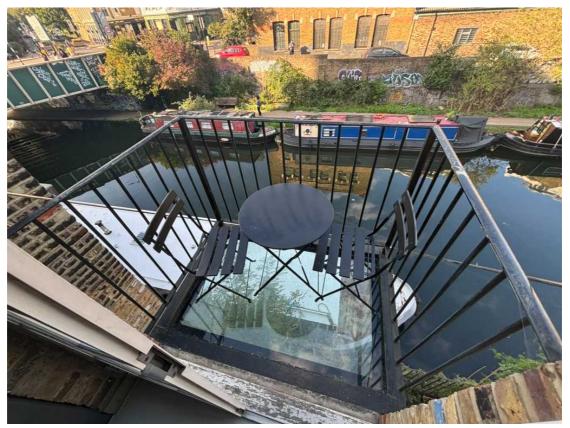
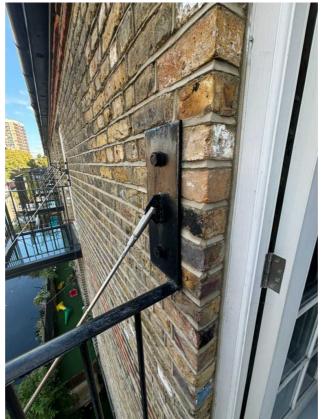
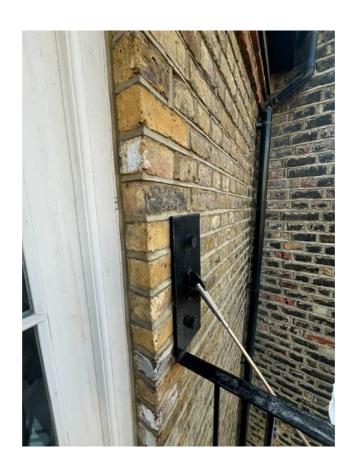
Overall, the balcony is in good condition, characterized by a durable glazed panel floor that shows no signs of cracking. The metal struts are securely fixed, with no corrosion evident, reflecting quality construction and maintenance. While there is minor moss growth, it can be easily managed through routine cleaning. With proper upkeep, this outdoor space can continue to serve as an attractive and functional extension of the living area.

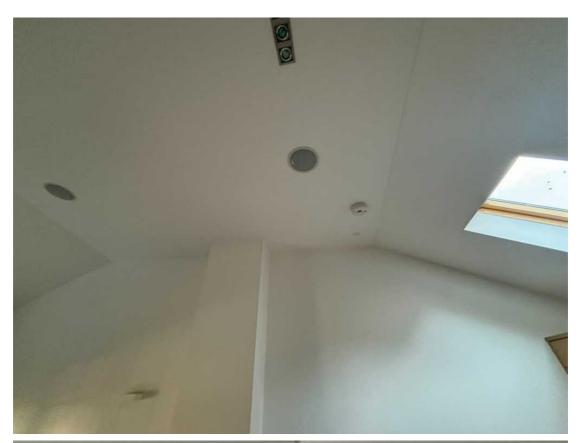
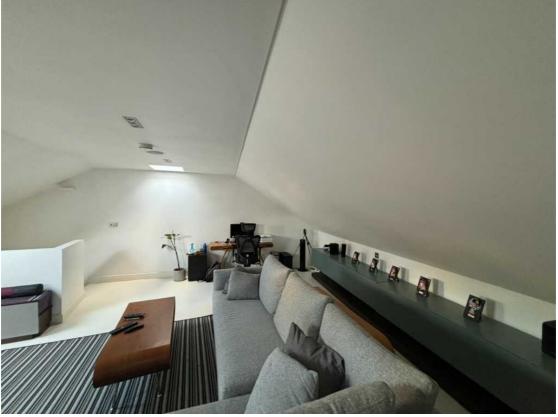
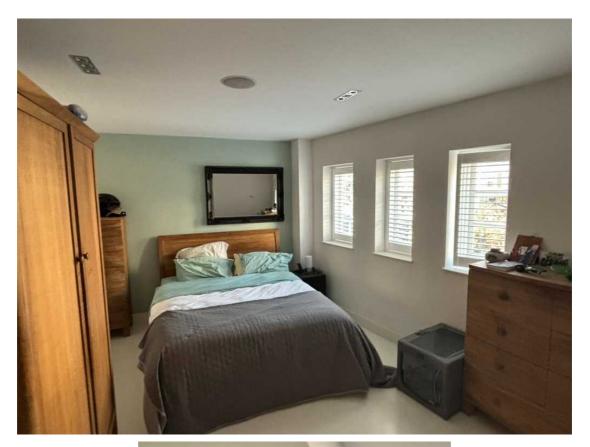
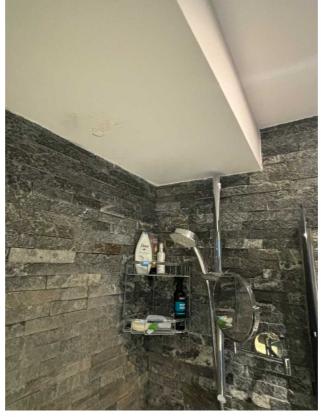
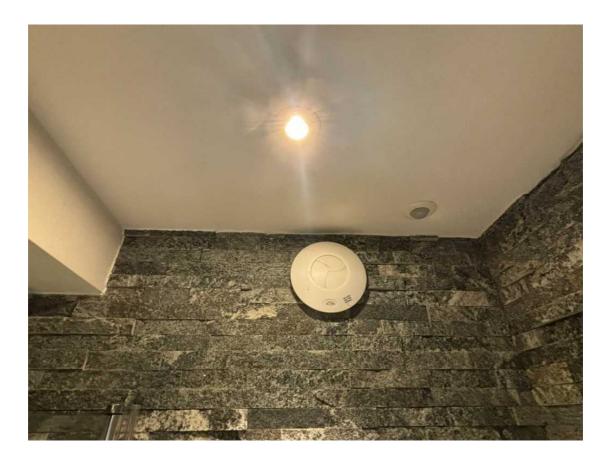
The ceilings throughout the property are finished with plasterboard and modern plaster, creating a clean and visually appealing environment. They are painted white and well-decorated, requiring minimal touch-ups. While the ceilings are flat and straight, there are some minor hairline cracks at the interfaces between the walls and ceilings. These are cosmetic and can be easily filled and redecorated. The bathroom ceiling exhibits signs of paint flaking near the shower, likely due to condensation from the extractor fan being turned off. Leaving the vent on is essential to maintain adequate ventilation and prevent further issues.

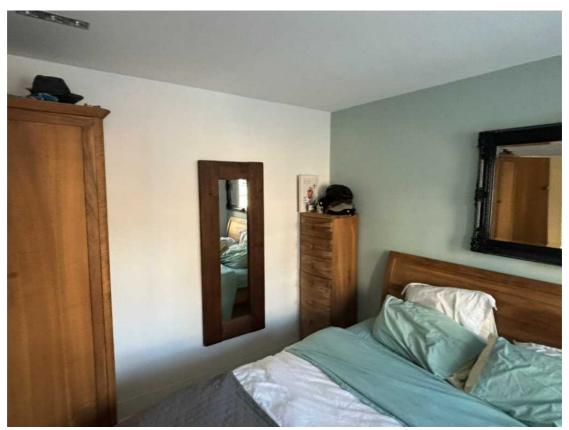
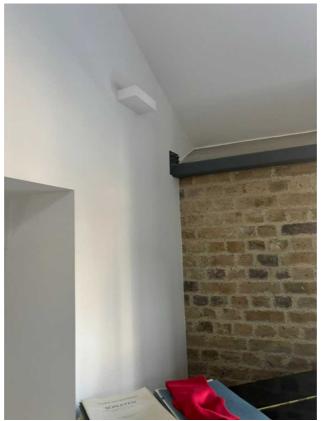
# E3 Walls and partitions

The walls throughout the property are finished with modern plaster and are well-decorated, presenting a clean and inviting atmosphere. They are painted white, requiring minimal maintenance and touch-ups. While the walls are generally in good condition, some minor hairline cracks can be observed at the interfaces with the ceilings. These cosmetic imperfections can be easily filled and redecorated as needed. Overall, the walls contribute positively to the aesthetic appeal of the living space, maintaining a fresh and contemporary look.

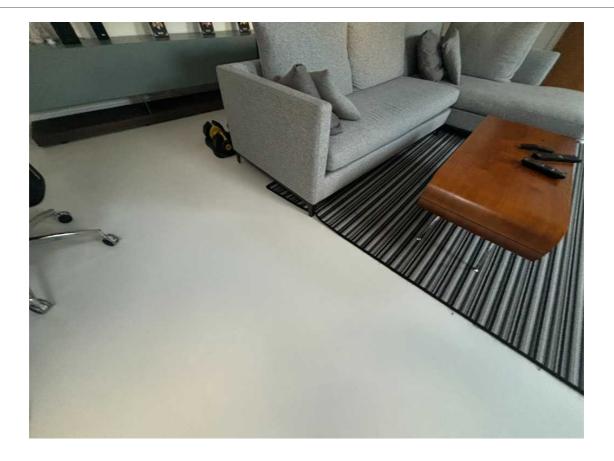
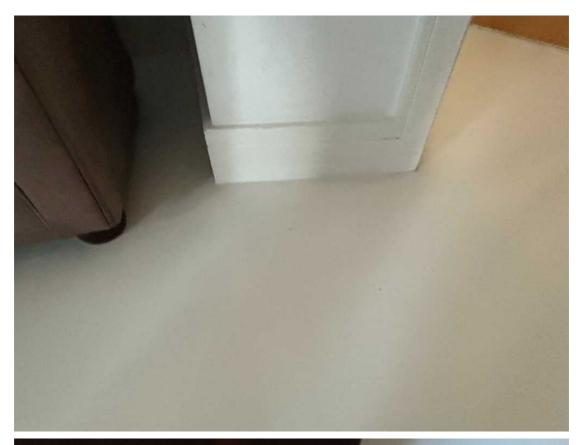
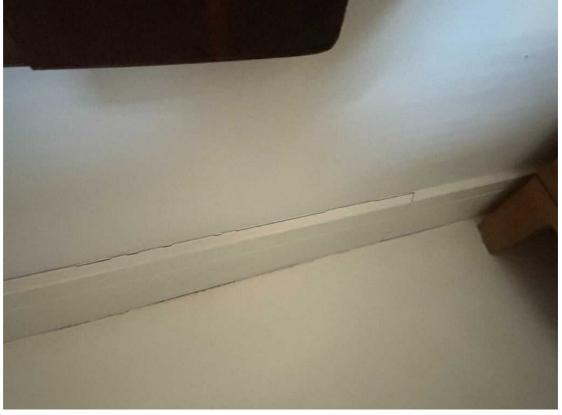
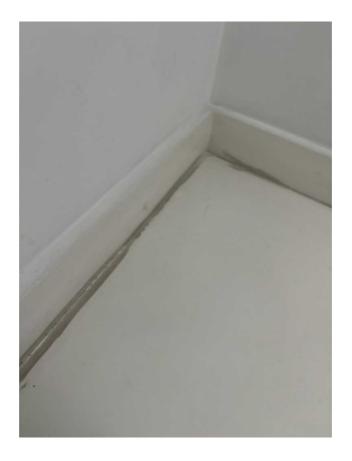
The flooring throughout the property features a visually appealing resin surface that is free from cracks. A suitable perimeter expansion gap has been installed to accommodate thermal expansion, ensuring the flooring remains intact under varying temperature conditions. However, there are areas around the perimeter of the floor where the mastic is missing or damaged. While this is purely an aesthetic issue, it may be something the buyer would want to address. The underfloor heating (UFH) present on the lower floor enhances comfort and efficiency, making this flooring an excellent choice for modern living. Regular maintenance will help preserve its quality and appearance over time.

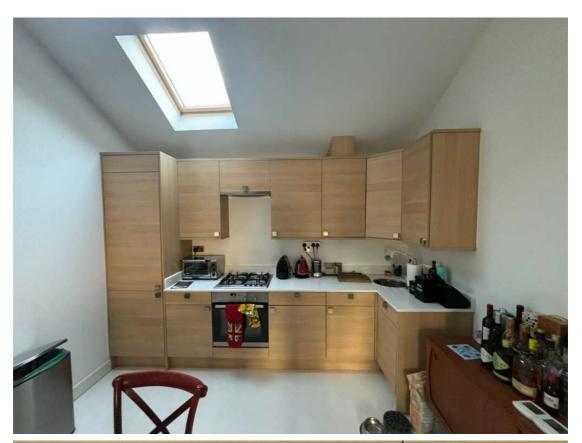
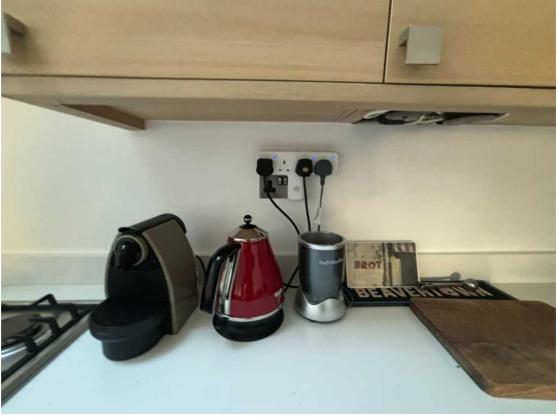
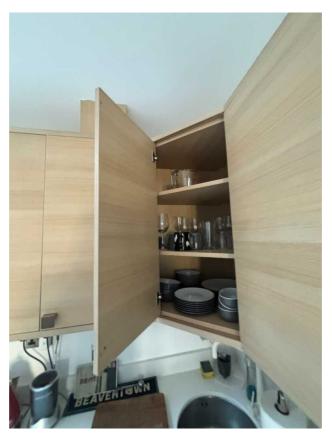
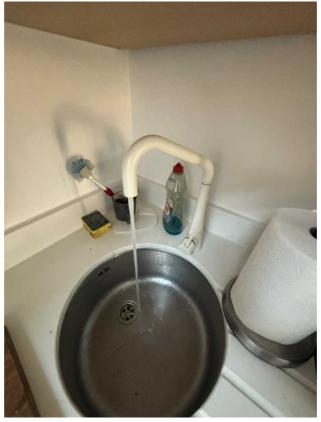
The built-in fittings in the kitchen, including the cabinetry, are in good order, contributing to the overall functionality and aesthetics of the space. However, one door may require a hinge adjustment to ensure smooth opening and closing. The worktop is in good condition, providing ample space for food preparation and other kitchen tasks. The tap delivers good water pressure, enhancing usability. It is noteworthy that an extension has been used on the splashback, so it may be beneficial to consider installing additional sockets for improved convenience and access.

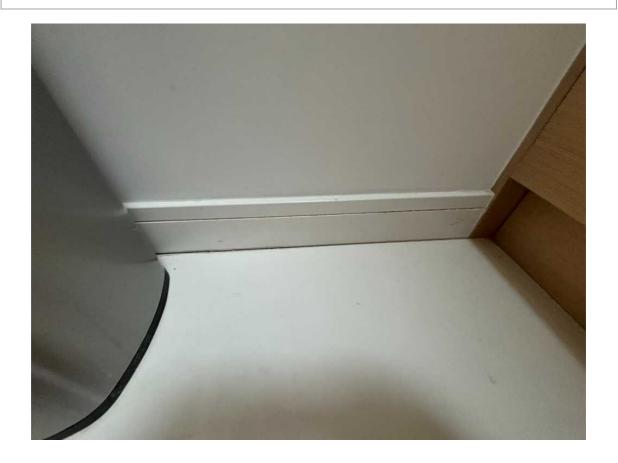
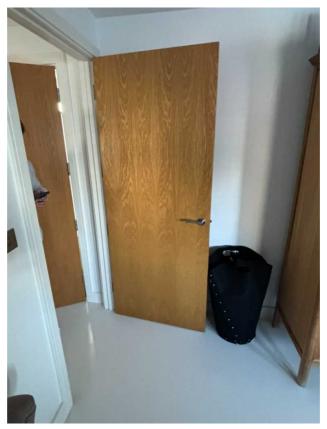
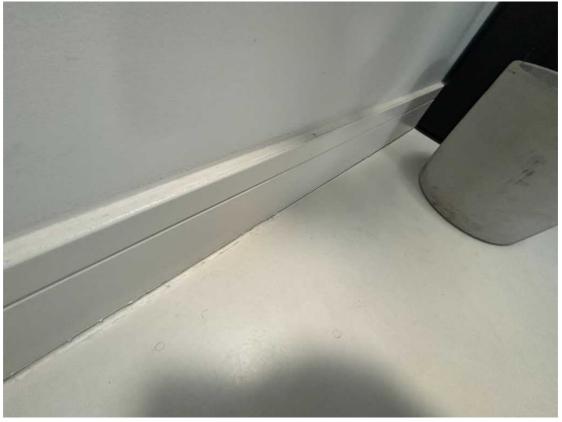
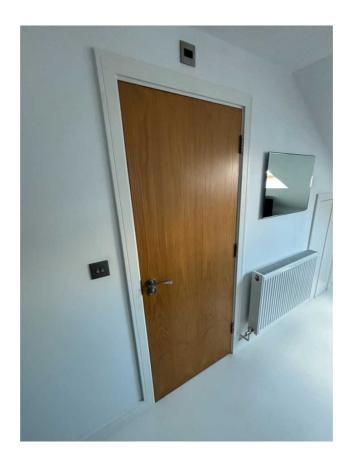
## E7 Woodwork (for example, staircase joinery)

The woodwork throughout the property is in excellent condition, with all doors fully operational and exhibiting no signs of bowing or warping. The skirting boards and architraves are straight and well-maintained, contributing to the overall aesthetic appeal of the space. The decoration is satisfactory, with only minor imperfections.

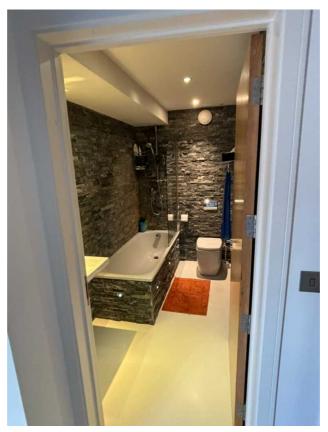
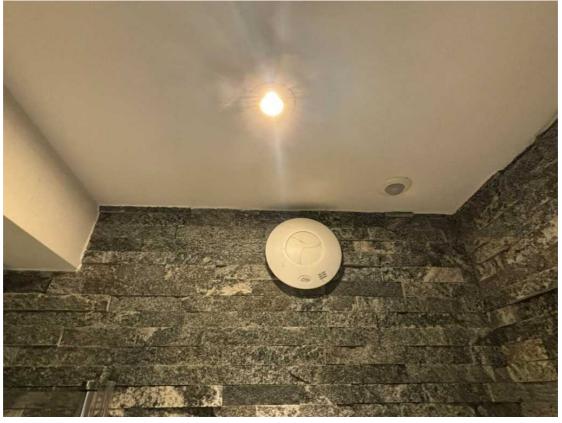
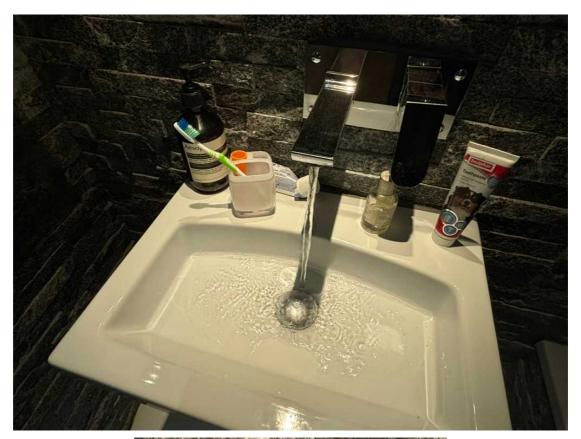
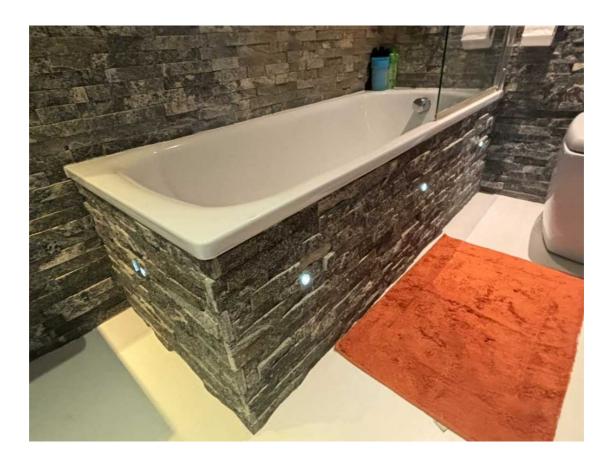
# **E8 Bathroom fittings**

The bathroom and en suite fittings are in excellent condition, with sanitaryware free from cracks or chips. Both areas show no signs of leaks, and the tiling is well-maintained. Good water pressure is noted in both bathrooms, enhancing their functionality. While there is some paint flaking near the shower head, likely due to condensation build-up, both ventilation fans were fully functional when turned on. It is essential to keep these vents operational to ensure adequate airflow and prevent further condensation-related issues.

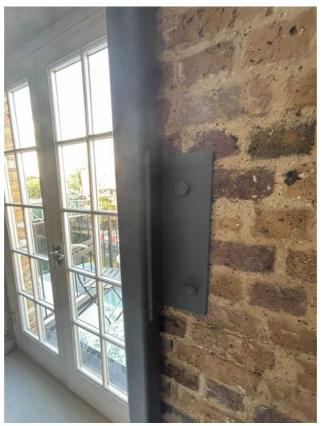
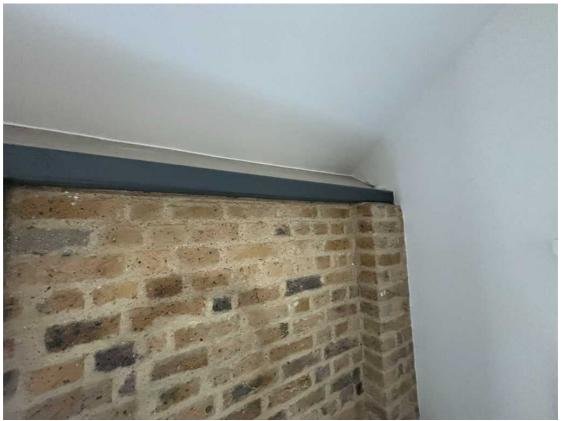
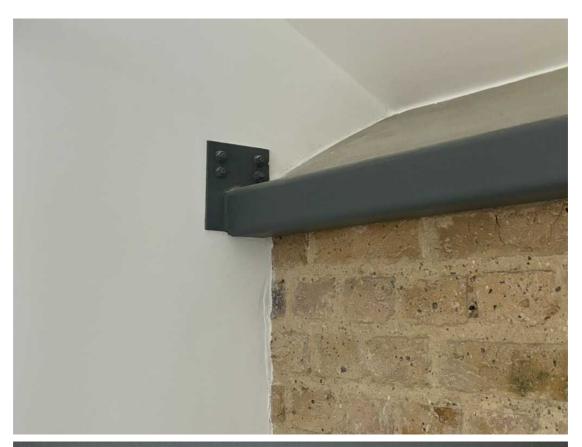
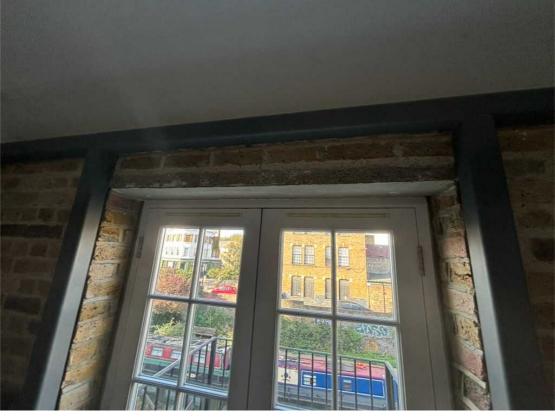
### E9 Other

The modern steel installations within the property serve as essential supports for the overall structure, providing enhanced stability. These steels are securely installed and remain in excellent condition, indicating a robust construction. They are finished to ensure adequate protection against environmental factors and exhibit no signs of deflection or damage, confirming their structural integrity. The fixings and bolt connections are appropriately sized and installed with precision, contributing to the overall safety and durability of the building.

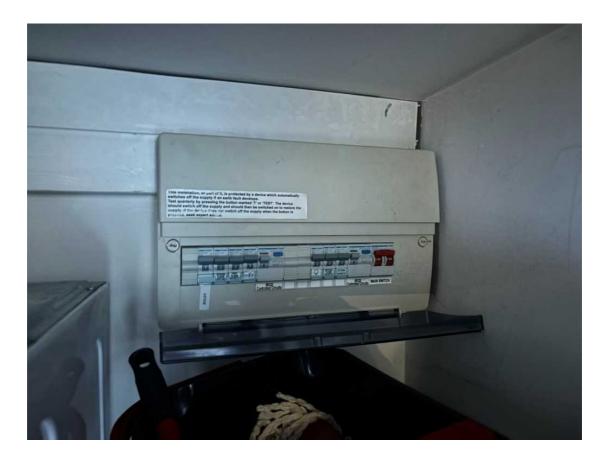
The electrical consumer unit is located in the storage cupboard under the stairs. The unit appears to be securely mounted and in good condition. The consumer unit shows no signs of wear or damage. The wiring connections are neat and properly insulated, indicating professional installation.

I would advise an NICEIC engineer to visit and advise on the installations. The NICEIC ensures that its members have systems in place to ensure that any businesses registered with them, and their employees are competent to undertake the work that they are contracted to complete.

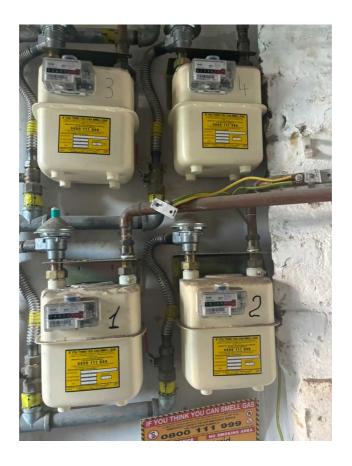
## F2 Gas/oil

The gas meter for the property is located in a shared service room accessible from the main street. This arrangement allows for convenient monitoring and maintenance of the gas supply. The installation appears to be compliant with safety regulations, providing a safe and efficient means of gas measurement for the property. Regular checks should be conducted to ensure the continued functionality and safety of the gas supply.

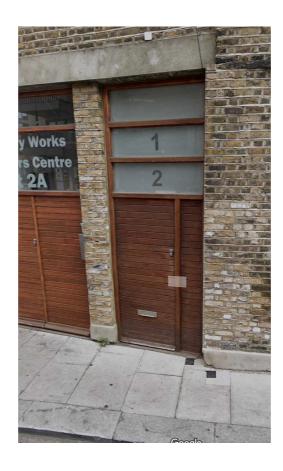
# F3 Water

The external stopcock access lid is conveniently located near the front entrance door to the communal area. It appears to be in good order, providing clear and easy access. It is essential to ensure that this area remains unobstructed at all times to facilitate quick access in case of emergencies or maintenance needs. Regular checks should be conducted to maintain its condition and accessibility.

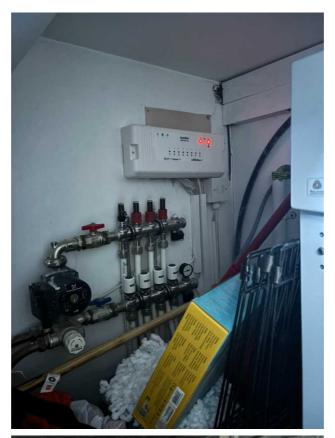
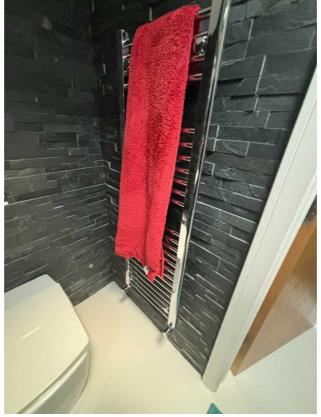
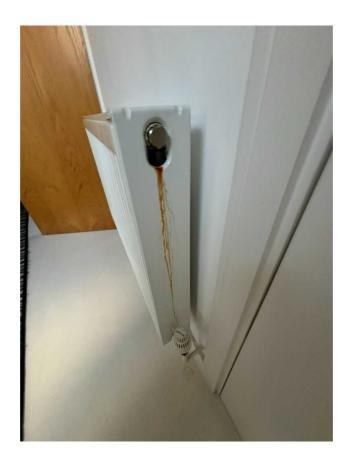
# F4 Heating

The property's heating system features a Valliant boiler housed within a kitchen cupboard. It is advisable to obtain warranty details and service records from the seller for verification. The lower level is fitted with underfloor heating, with the manifold located in the storage cupboard under the stairs; connections are secure with no signs of leaks. The upper level is heated by radiators, with one in the bedroom and another in the en suite. A minor leak was noted at the bedroom radiator, but it appears historical, as the surrounding area is dry with no signs of water damage.

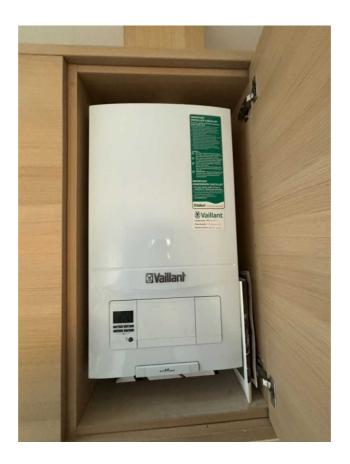
# **F5 Water Heating**

The property's water heating system comprises a Valliant boiler, located within a kitchen cupboard. It is advisable to request the warranty details and service records from the seller to confirm the boiler's maintenance history and any ongoing coverage or support.

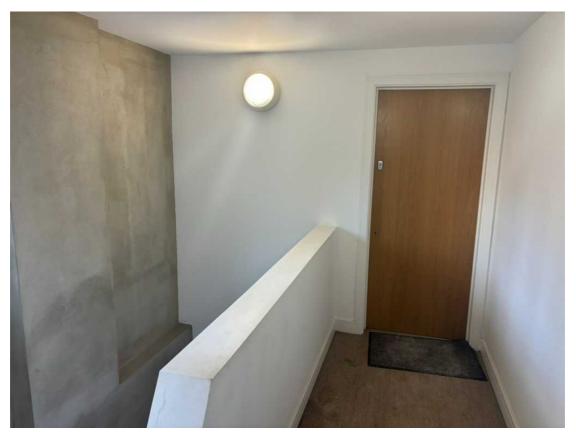
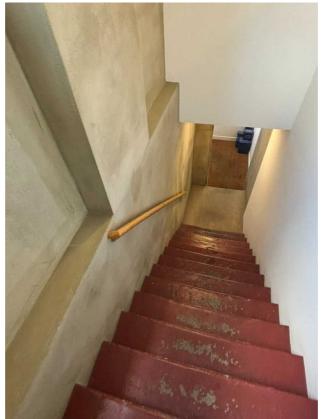
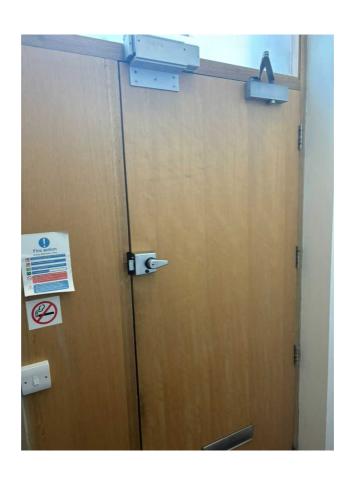
The common services within the property are well-maintained and functional, contributing to the overall efficiency and safety of the building. The presence of a solid fire door adds to the safety features of the shared space, ensuring compliance with fire safety regulations. Additionally, the clear signage regarding fire action protocols further enhances safety awareness among residents. Regular maintenance and inspections of these common services will ensure their continued effectiveness and reliability.

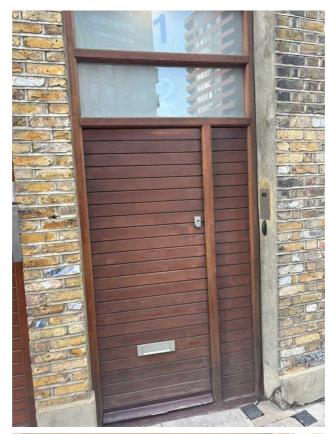
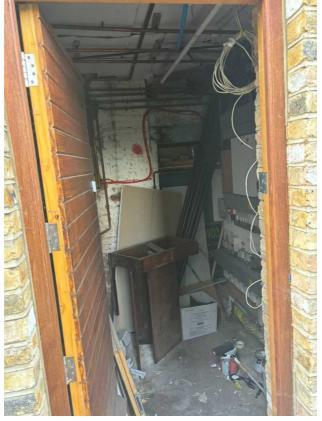
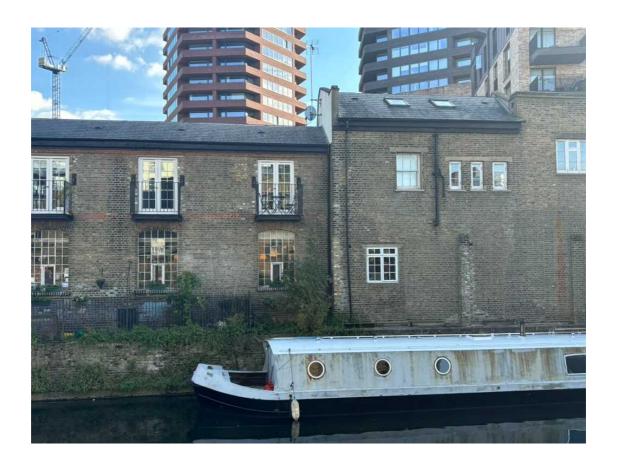
The property is beautifully situated alongside a canal, which enhances its charm and provides picturesque views for residents. The front entrance door to the communal area is conveniently located on the ground floor of the main street, which is well-maintained and inviting. Adjacent to this entrance, the shared utility room houses the electrical and gas meters, and it is secure and in good condition. Notably, the doors show no signs of bowing or warping, ensuring their functionality and security.
