Your survey report

160 Dartmath Road, London, United Kingdom, SE22 3LQ

21/01/2025

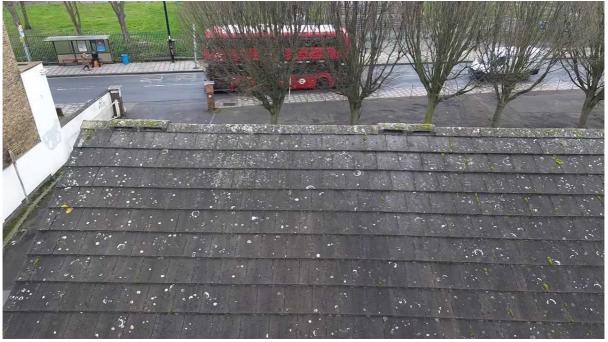
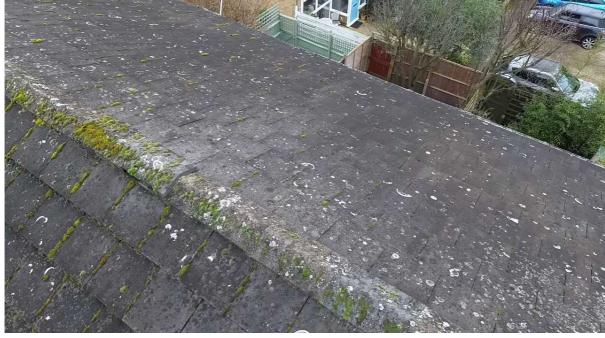
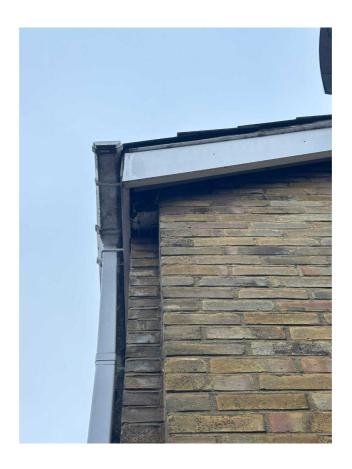
The roof is covered with concrete tiles, which appear to be in good condition overall. Moss is present on some of the tiles, which should be monitored and cleared to prevent water retention and potential damage over time. There are no missing tiles, and the ridge line remains straight with ridge tiles in good order. Ridge vents are properly installed and functioning as intended.

The fascia and bargeboards are in good order, and the verge mortar is intact with no signs of deterioration. The soffits are generally in good condition, except for the front corner soffit boards, which show slight degradation and looseness. These should be repaired or replaced to prevent further issues.

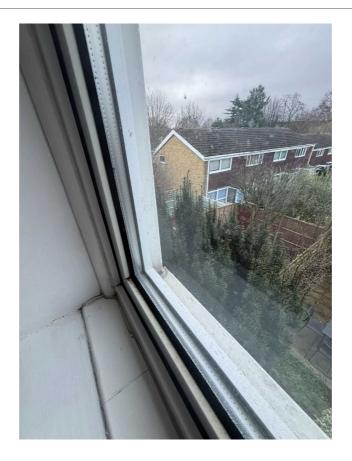
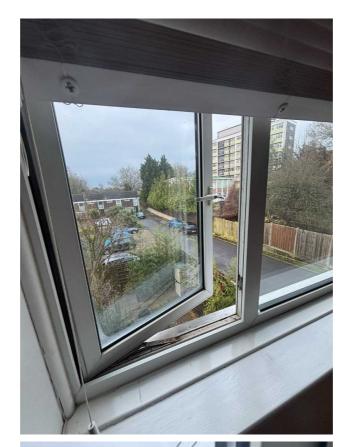
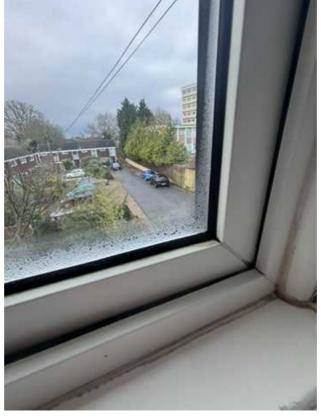
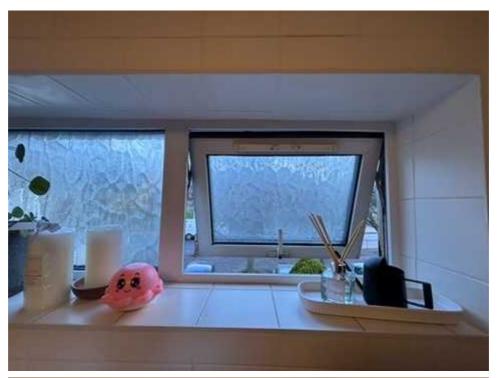
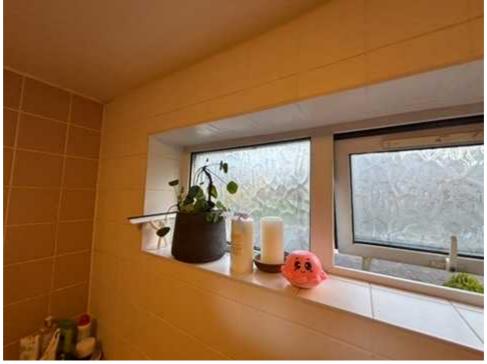
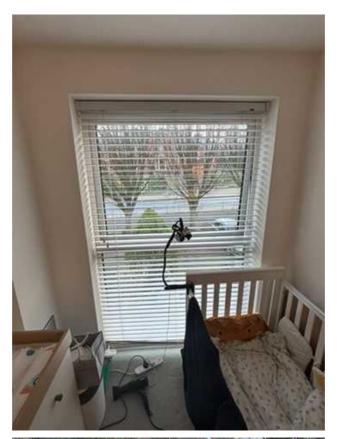
The windows are modern double-glazed casement windows, all of which are operational and fitted with locks, ensuring security. There are no visible cracks in the panes, which indicates that the glazing is in good condition. The seals around the windows are intact, which is a positive sign that the windows are providing effective insulation, both thermally and acoustically, helping to maintain energy efficiency and minimise external noise.

The uPVC frames are also in good condition, with no defects or damage noted. The frames are securely fixed and show no signs of wear or deterioration, such as cracking or bowing, which would indicate potential structural issues or water ingress. Overall, the windows are functioning as intended, contributing to the property's overall energy efficiency and security.

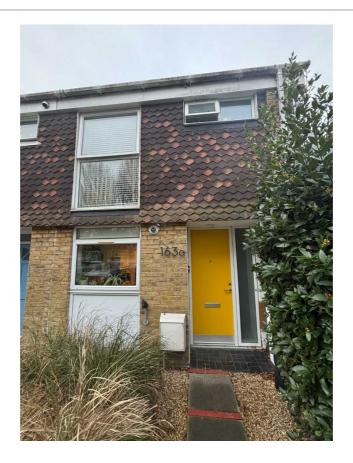
The front door is a bright yellow timber door, which adds a distinctive feature to the property's facade. It is in good condition and fully operational. Adjacent to the door is a small, well-maintained white letterbox, and the space around it is kept clear of obstructions.

Overall, the porch area is clean, functional, and aesthetically appealing, offering a pleasant first impression of the property.

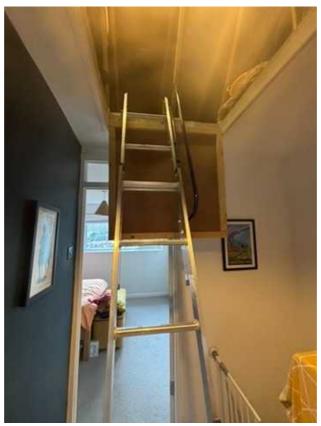
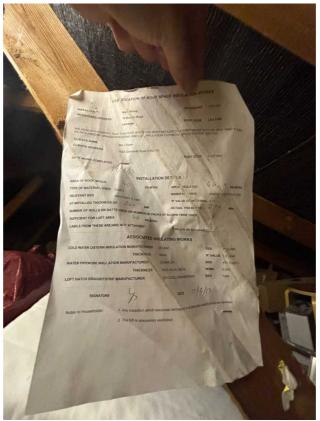
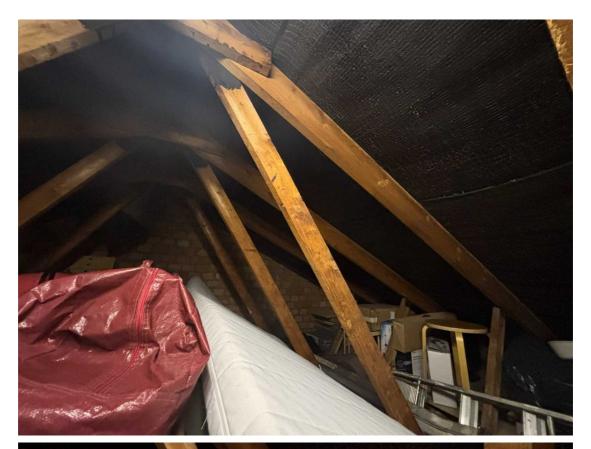
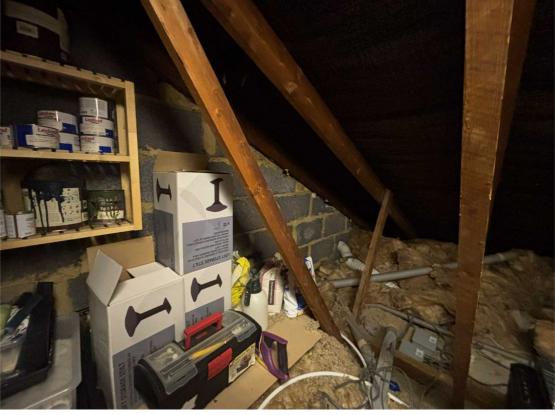
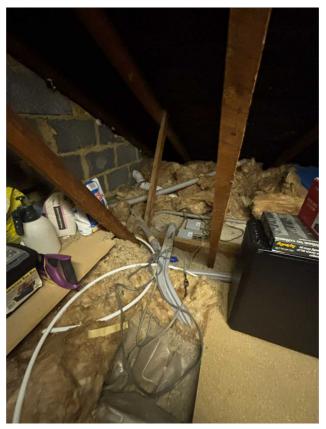
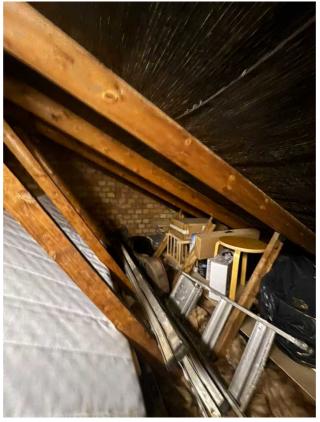
The sarking layer, which is essential for providing additional weather protection, is also in good order, showing no signs of wear or deterioration. The party wall, made of brick and block work, is suitably sealed to ensure it provides the necessary fire protection, with no gaps or areas of concern.

Additionally, there are no signs of woodworm or beetle infestation in the timber, and the timbers themselves show no signs of deflection that would indicate overloading or structural issues. This suggests that the roof structure is stable and in sound condition, with no major concerns regarding the overall integrity or load-bearing capacity.

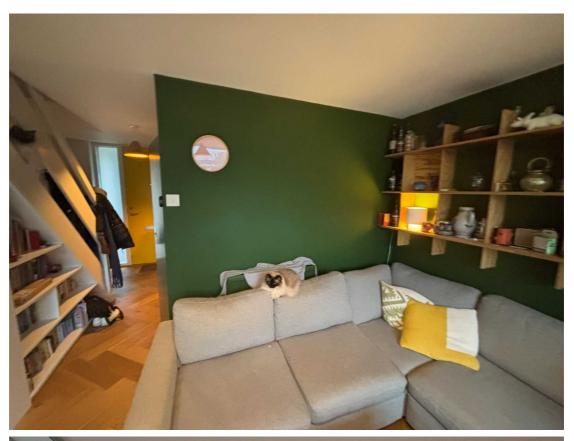
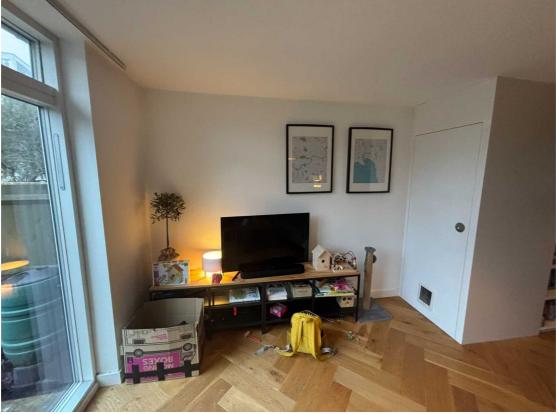
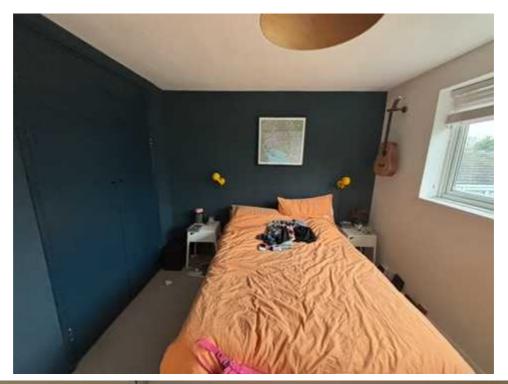
The walls are generally in good condition, with only minor hairline cracks in some areas. These are common in many properties and are cosmetic in nature, requiring only filling and decorating to restore the smooth surface. There are no damp patches evident that would suggest leaks from services, such as plumbing, or from the roof system. Additionally, there are no signs of rising damp, indicating that the damp proof course (DPC) is performing effectively.

No significant defects were observed in the walls that would suggest any structural issues, such as bowing, cracking, or settlement. The overall condition of the walls is sound, and no immediate concerns were noted regarding the building's structural integrity.

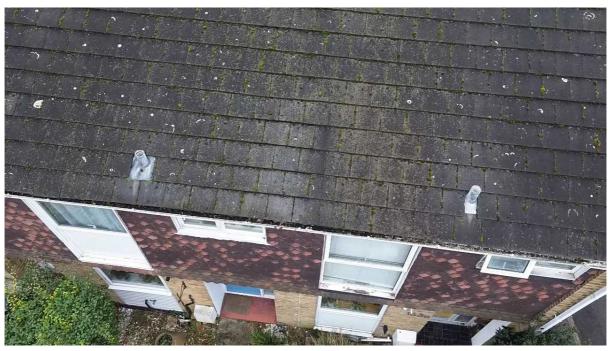
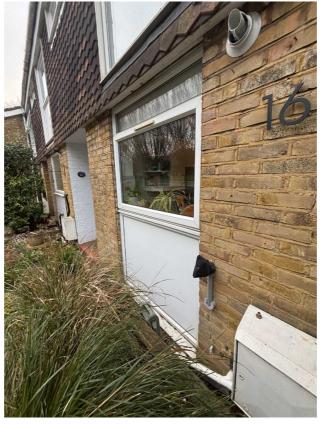
E5 Fireplaces, chimney breasts and flues

There are no fireplaces in the property. However, there are two flues present. One flue exits from the roof and is believed to provide ventilation for the mechanical vent in the bathroom. The other flue vent exits from the kitchen and serves the boiler. Both flues appear to be in good order, with no obvious signs of blockages or damage. Proper ventilation is essential for both systems, and it is important that these flues remain clear to ensure efficient operation and prevent any potential issues with airflow or moisture buildup. Regular checks should be made to maintain their functionality.

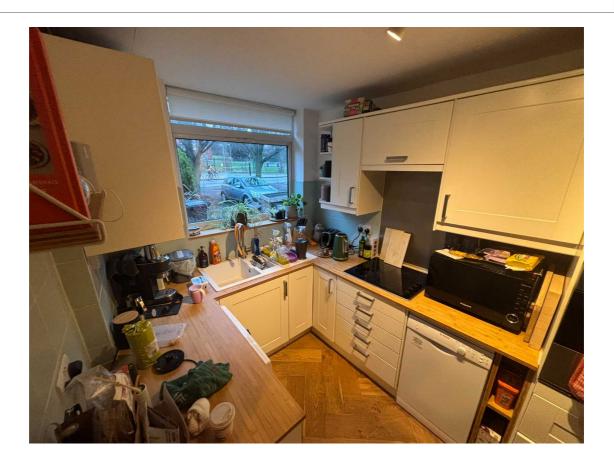
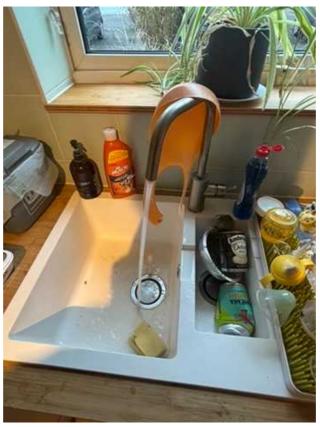
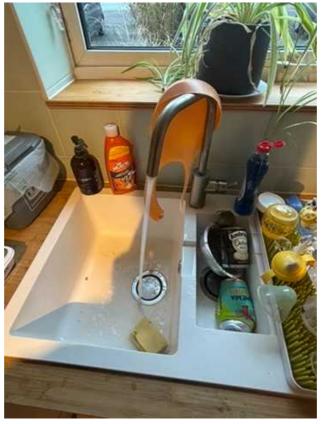
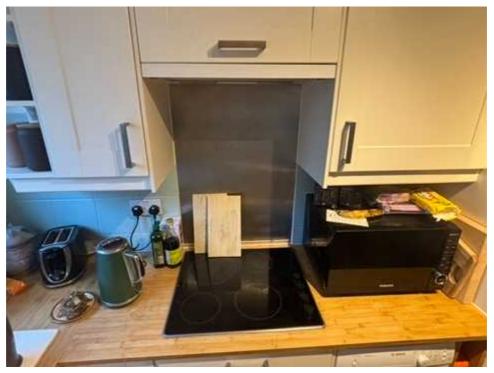
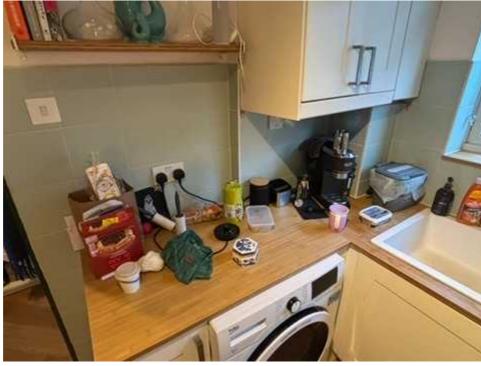
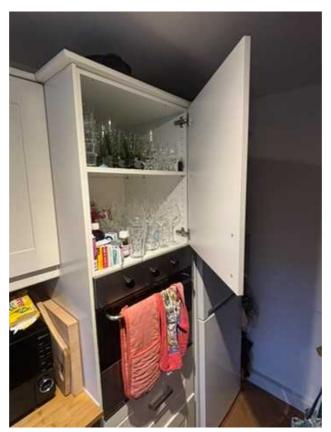
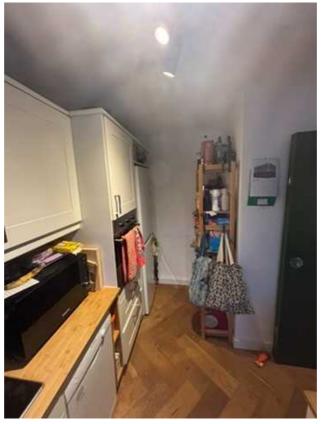
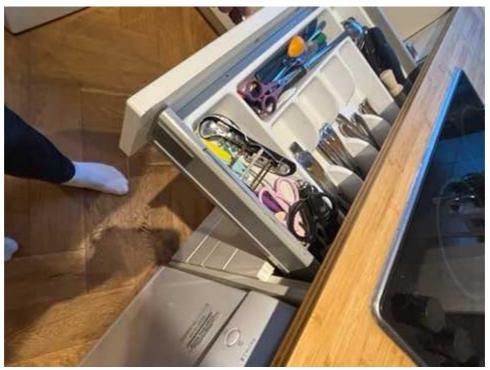
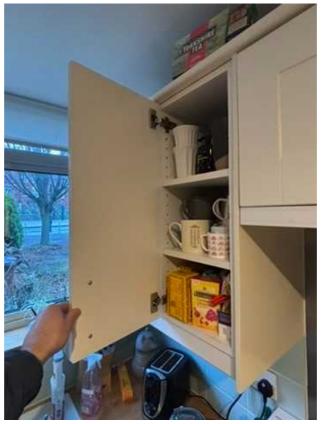
E6 Built-in fittings (built-in kitchen and other fittings, not including appliances)

The kitchen is well-maintained, with the key elements in good condition. The sink is in good order with no visible damage. The tap is functioning properly, providing good water pressure, and there are no signs of leaks from the plumbing underneath, suggesting everything is sealed and installed correctly.

The worktop appears to be in good condition, with no signs of significant wear, damage, or staining. It is well-maintained, contributing to a clean and practical workspace. The cabinetry is also in good order, with all doors and drawers functioning smoothly and securely. There are no signs of damage, warping, or loose fittings, which suggests solid installation and ongoing care.

The appliances in the kitchen, including the washing machine, oven, and dishwasher, appear to be in good working order based on their condition and placement, though they were not tested during the inspection. These appliances are well-integrated into the kitchen layout and do not show any signs of damage or wear.

The tiled splashback is in good order, with no broken or missing tiles. It is functional and adds to the aesthetic of the kitchen, providing protection from moisture and stains in key areas like the cooking and sink zones.

Overall, the kitchen is in good condition, with all essential elements well-maintained. No immediate issues were identified, and the space remains functional and aesthetically pleasing. Regular cleaning and maintenance will ensure the kitchen continues to perform well.

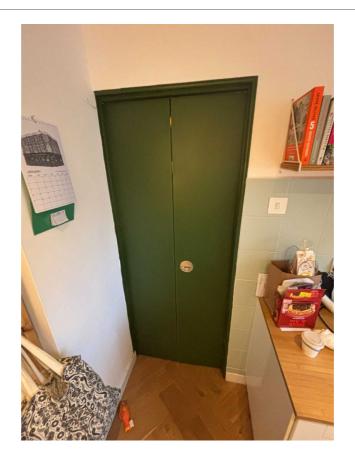
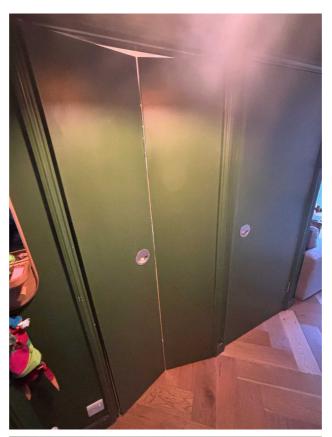
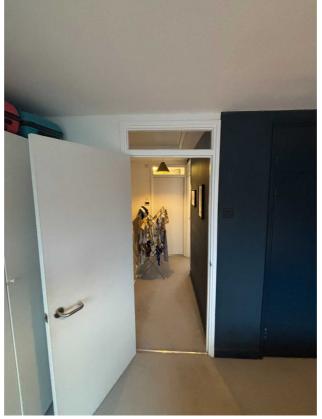
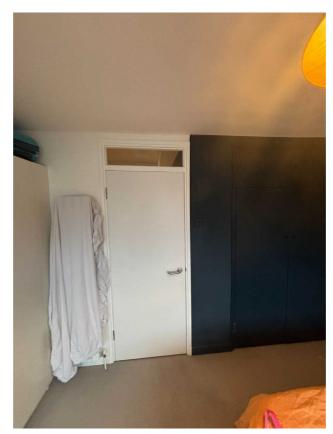
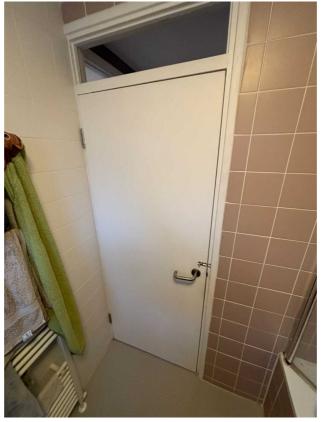
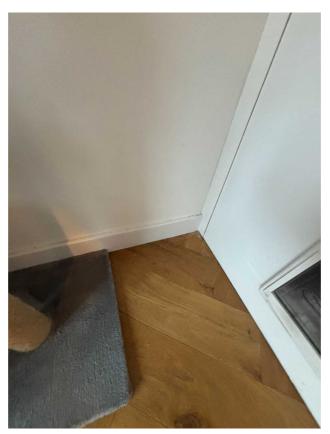
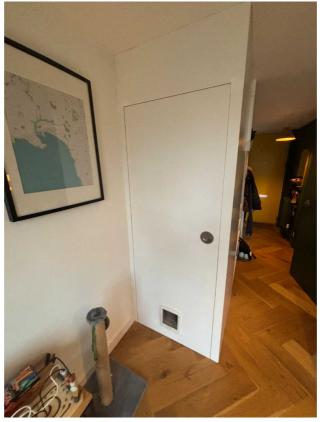
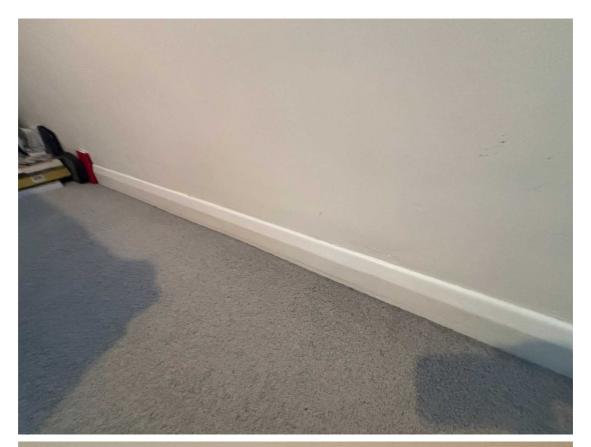
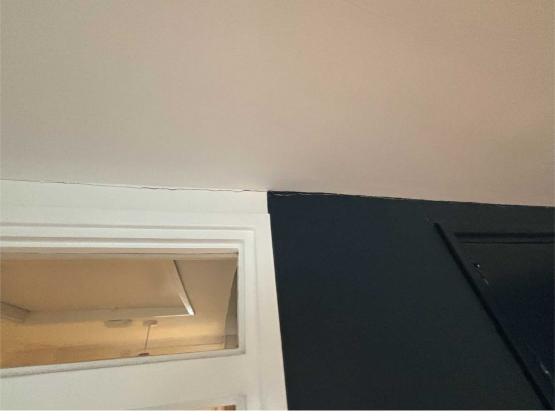
The woodwork throughout the property is generally in good condition, with all doors, skirtings, architraves, and bannisters well-maintained. The doors are all functioning as intended, with no signs of damage or warping. The door frames, including those leading to rooms such as the bathroom and bedrooms, are securely fitted and show no significant signs of wear or damage. The painted finish on most of the doors is in good condition, providing a clean and neat appearance.

The skirtings and architraves are also in good condition, with no visible gaps or damage. The paintwork is generally well-preserved, although some minor touch-ups may be needed in high-traffic areas or where the paint has slightly worn. The architraves around doorways are well-finished and complement the overall decor of the rooms.

The bannister, visible in the stairwell, is solid and in good working order. It is securely fixed and provides adequate support for use on the stairs. There is no visible deterioration, and the paintwork on the bannister is in good condition, though a fresh coat of paint may be beneficial in areas with high wear.

Overall, the woodwork is in excellent condition, with no significant defects or damage. The finish is clean, and everything appears secure, contributing to the overall aesthetic and functionality of the property. Regular maintenance such as occasional touch-ups or refinishing of high-traffic areas would help preserve the quality of the woodwork.

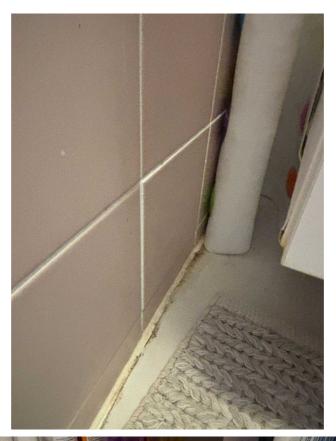
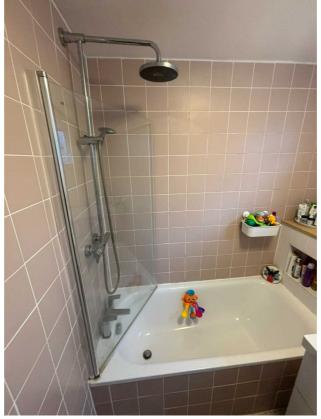
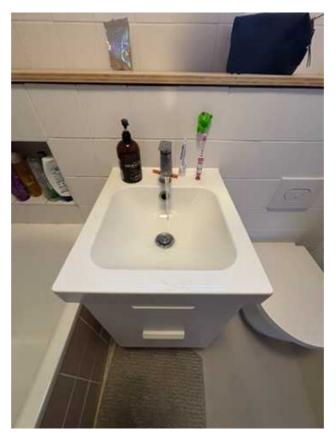
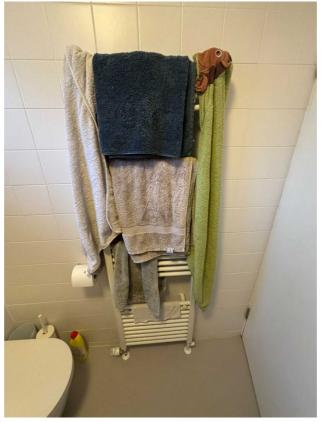
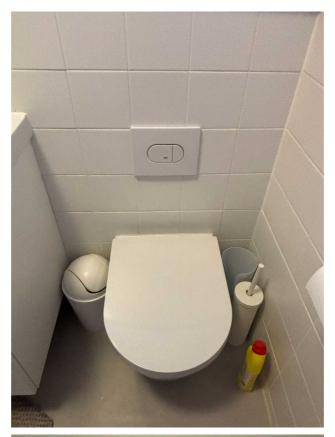
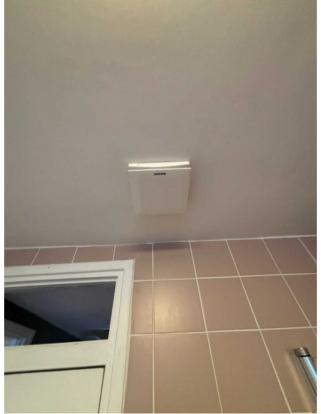
E8 Bathroom fittings

The bathroom is in good condition overall, with the sanitaryware in good order, showing no signs of damage or wear. The tiles are well-maintained, with no cracked or missing sections, and they contribute to the overall aesthetic of the room. However, the grout joints have become discoloured and show signs of minor mould growth, which suggests that a deep clean would be beneficial to restore their appearance and prevent further mould buildup.

The mastic around the bath and sink is intact, but, like the grout, it shows minor mould growth in places. This can be cleaned or replaced as part of routine maintenance to maintain hygiene and prevent any further mould spread.

Water pressure in the bathroom is good, providing an efficient and comfortable shower or bath experience. However, the plumbing is largely concealed, so it was not possible to inspect it in detail. Given the lack of visible leaks or issues, it can be assumed to be in good working order.

The vinyl flooring in the bathroom is in good condition, with no visible damage, tears, or signs of wear. It is easy to maintain and contributes to the overall cleanliness and functionality of the space.

Overall, the bathroom is in good condition but would benefit from some deep cleaning, particularly in areas affected by mould and soap scum, to maintain its appearance and hygiene.

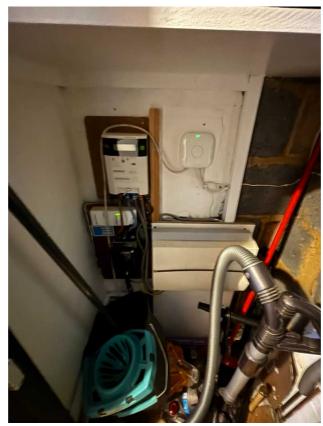
The electrical consumer unit appears to be modern and in good condition, with the necessary Residual Current Devices (RCDs) in place, providing enhanced protection against electric shocks and ensuring the safety of the electrical system. The consumer unit is well-maintained, with no visible signs of damage or wear. The electrical meter is also present and appears to be functioning properly, suggesting that the property's electricity consumption is being accurately monitored.

There is no noticeable damage to any of the sockets or light switches within the property. All seem to be securely fixed in place and free from cracks, scorch marks, or other signs of electrical issues, which is a positive indicator of the system's condition.

However, it is still advisable to request an Electrical Installation Condition Report (EICR) to ensure the electrical system is fully compliant with current safety standards and to identify any potential underlying issues that may not be immediately visible. An EICR provides a thorough assessment of the wiring and electrical installations, checking for any faults, deterioration, or hazards that could pose a risk in the future. Regular EICR checks are recommended to maintain electrical safety in any property.

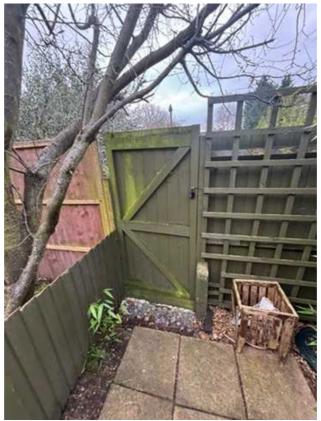
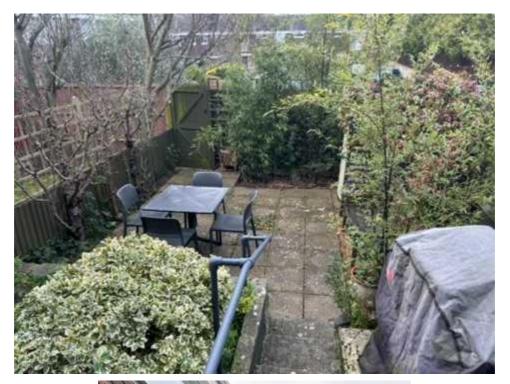
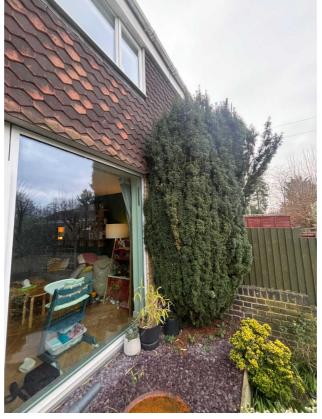
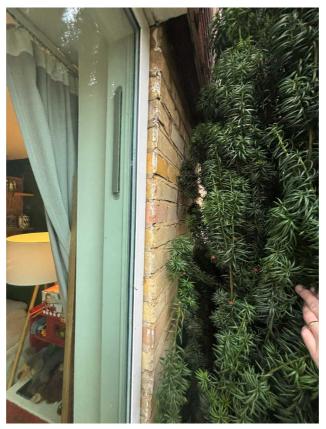
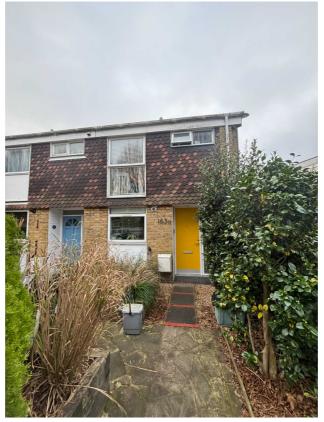
There is a **tree situated up against the side of the house**, which warrants closer attention. While the tree does not appear to be currently causing any damage, trees in close proximity to buildings can present certain risks, especially as they grow and their root systems expand.

However, there are **no visible signs of cracking or distortion** on the wall of the property in the vicinity of the tree, which suggests that the tree is **not currently causing structural issues** or damaging the building. The absence of noticeable cracks or movement is a good indication that, at present, the tree's roots or branches are not affecting the structural integrity of the property.

Overall, while the tree is not currently causing issues, it is wise to remain vigilant to avoid potential future complications. Regular maintenance of the tree and the structure of the house will help mitigate any risks.
